# Your Inspection Report

75 Bertmount Avenue  
Toronto, ON M4M 2X8

Thursday, February 21, 2019

RE: Report No. 2709, v.4  
75 Bertmount Avenue  
Toronto, ON  
M4M 2X8

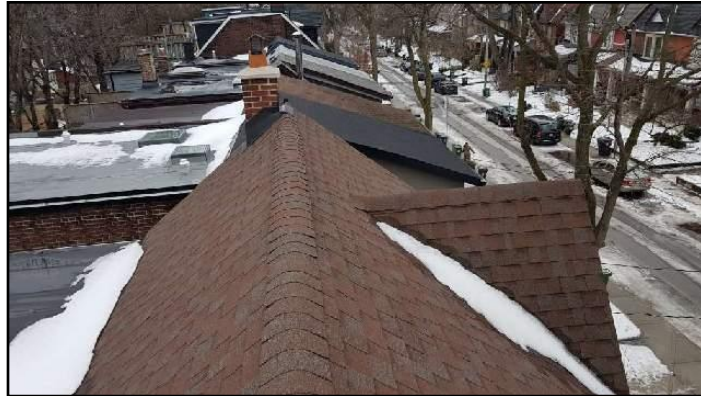
1. Asphalt shingles

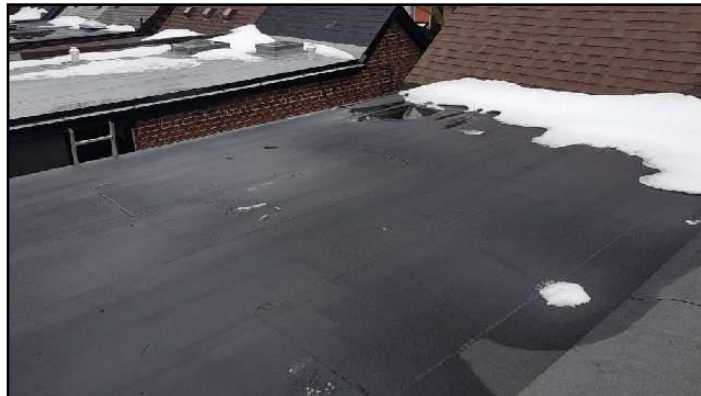
2. Modified bitumen membrane

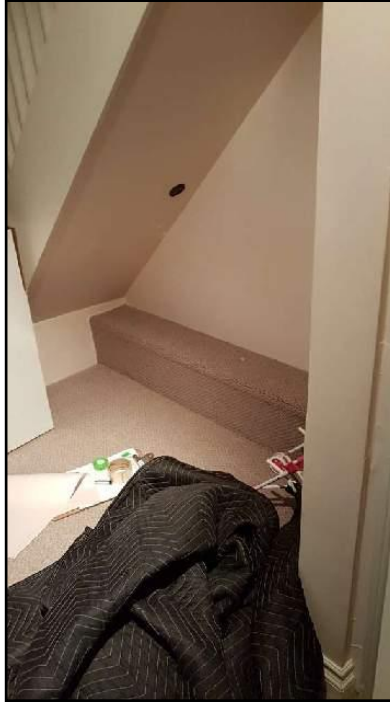
4. Basement lowered.

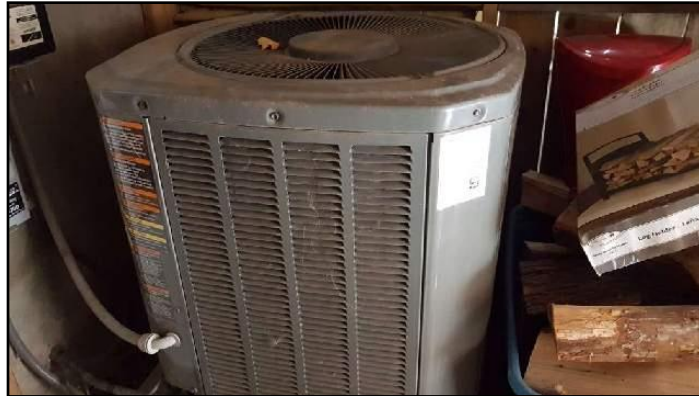
5. Central

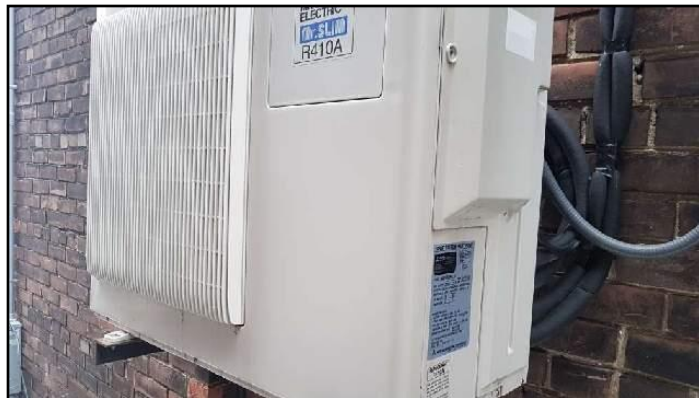
6. Ductless (Mini split) system

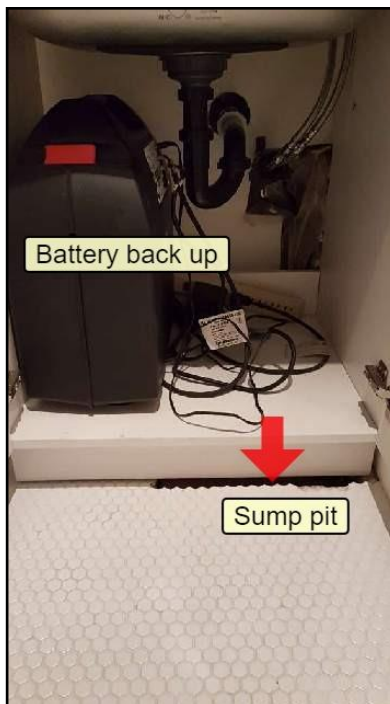
7. Sump pump

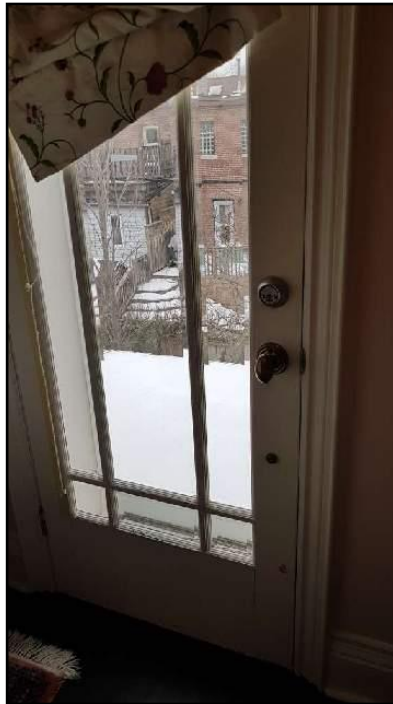
8.

**12. Condition:** • Add guardrail at east bedroom door to exterior to prevent access to deck roof.
