Your Inspection Report

13 Rushbrooke Avenue
Toronto, ON M4M 3A8

Tuesday, September 29, 2020

RE: Report No. 3166
13 Rushbrooke Avenue
Toronto, ON
M4M 3A8

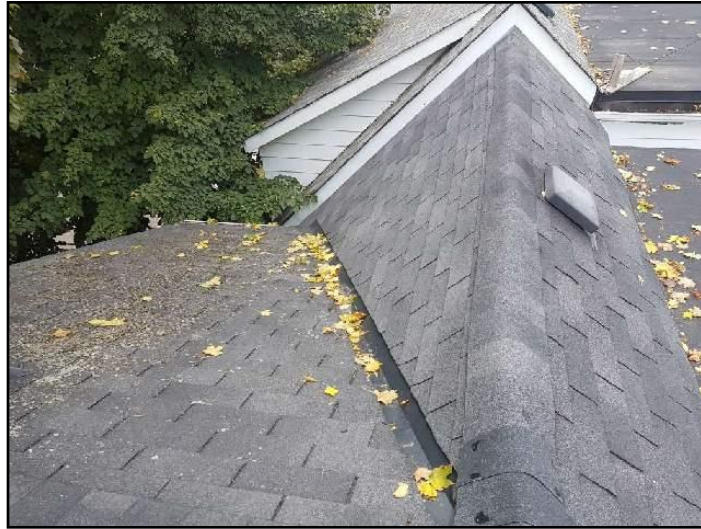
Sloped roofing material:

1. Asphalt shingles

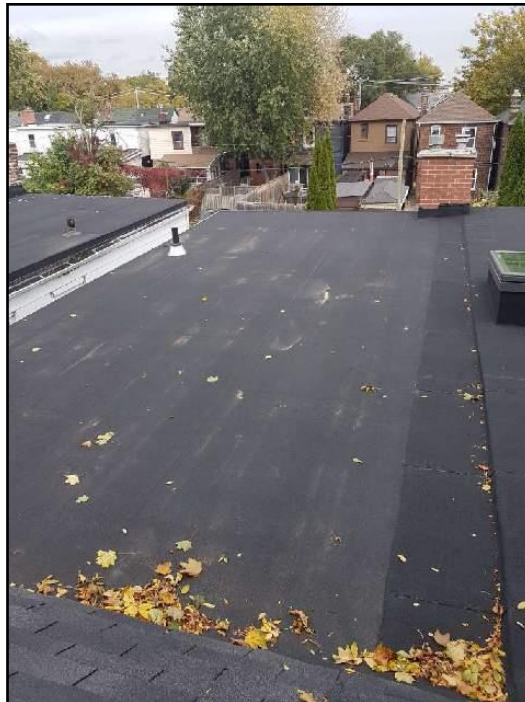
Flat roofing material:

2. Modified bitumen membrane

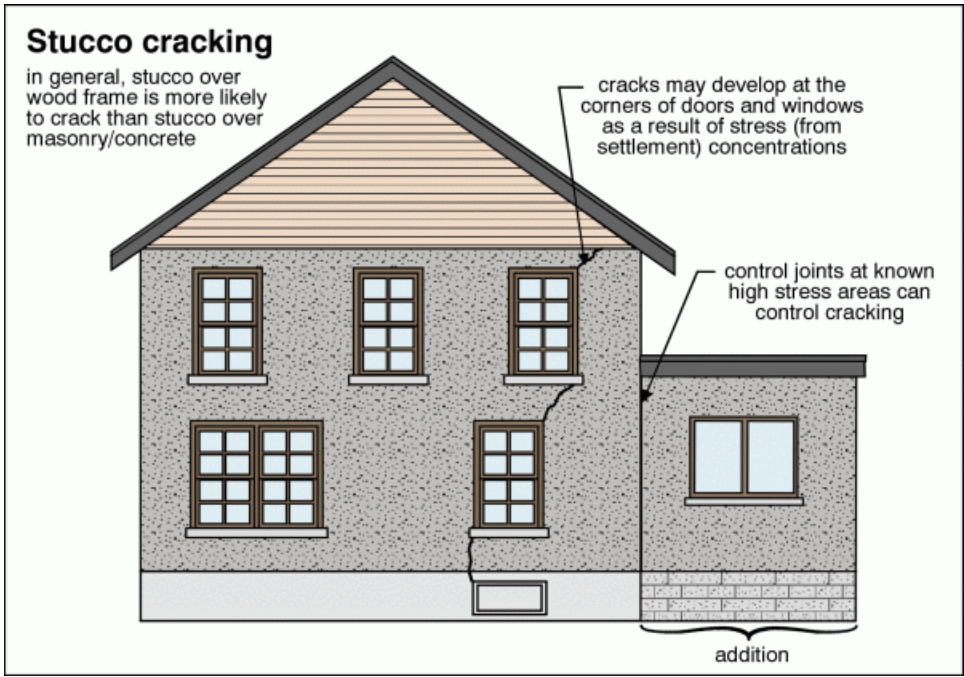
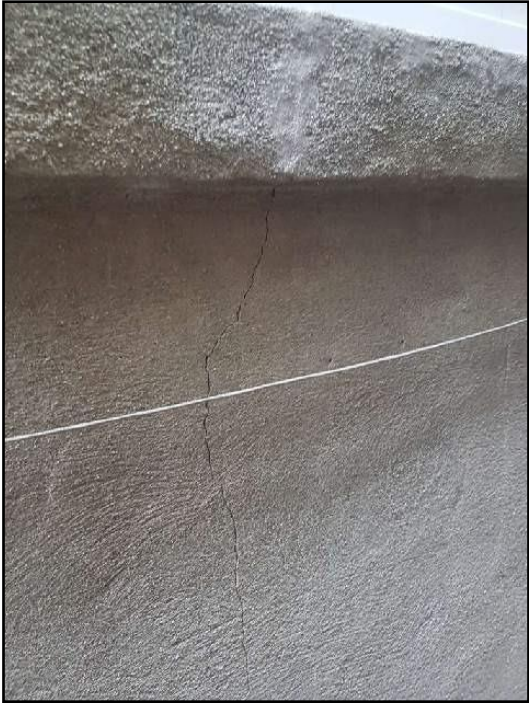
2. Condition: • [Cracked](#)

Typical minor cracks are not structurally significant.

Implication(s): Chance of water damage to structure, finishes and contents | Material deterioration

Location: Various Exterior Wall

3. Cracked

Task: Repair

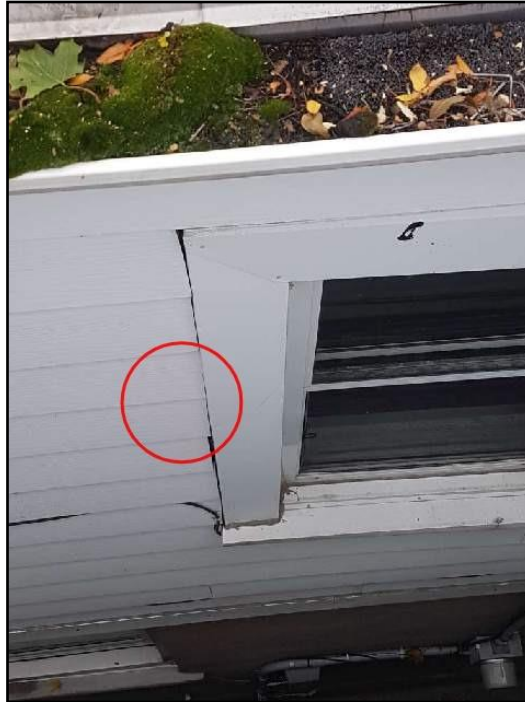
3. Condition: • Flashings incomplete.
Seal joint where siding meets trim.

Location: North Second Floor Windows

4. Flashings incomplete.

Task: Repair
Time: Immediate
Cost: Minor

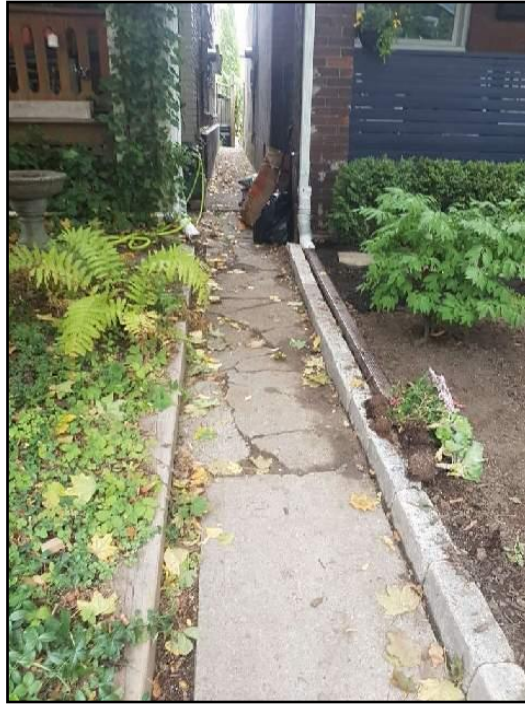
4. **Condition:** • [Cracked or damaged surfaces](#)

Implication(s): Trip or fall hazard

Location: North Exterior

5. Cracked or damaged surfaces

Task: Improve

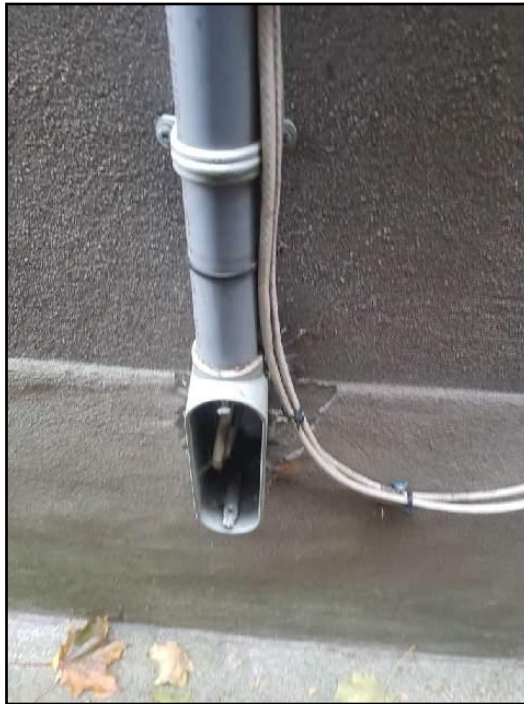
6. Condition: • Replace missing cover at base of conduit.

Location: North Exterior Wall

Task: Repair

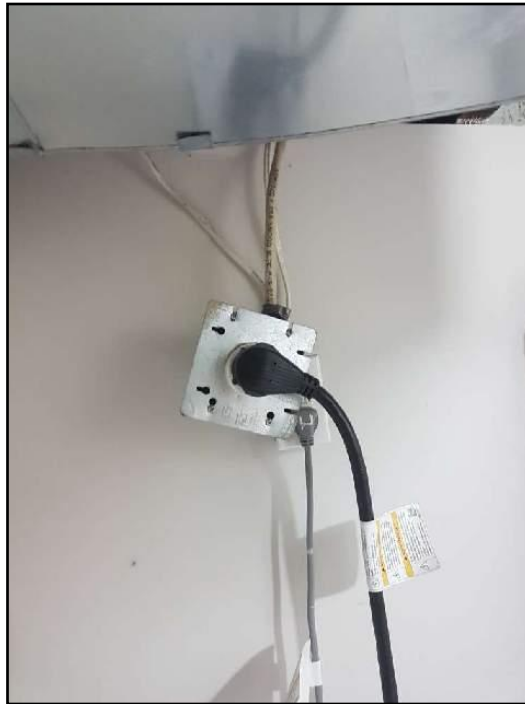
7. Condition: • [Not well secured](#)

Implication(s): Electric shock | Fire hazard

Location: Basement Laundry Area

7. Not well secured

Secure outlets and wiring to wall.

SELLERS NOTE:
THIS HAS BEEN CAPPED AND SEALED.

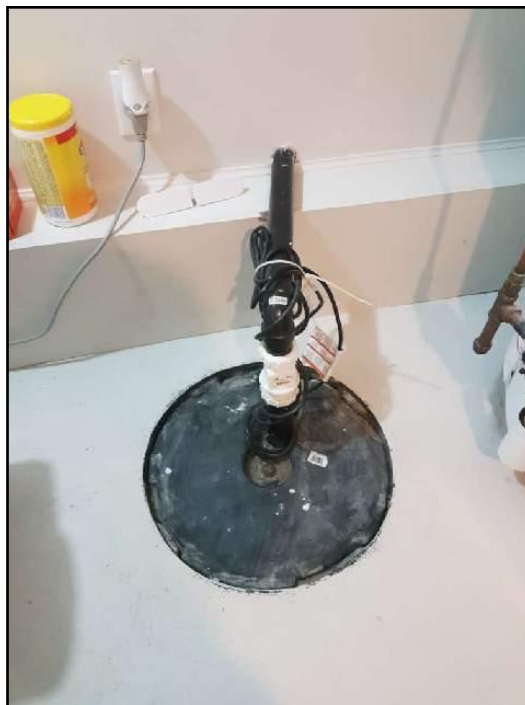
8. Sump pump

Sump pump is unplugged, leave plugged in at all times. Insurance company may request back up system.

13. Condition: • Consider back up pump and battery back up at sump system.

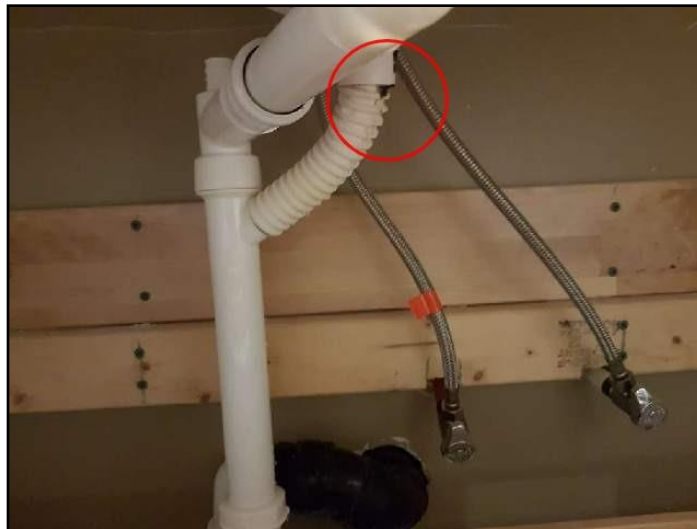
12. Condition: • [Leak](#)

Implication(s): Sewage entering the building

Location: Second Floor Bathroom

9. Leak

Repair leak under bathroom sink.

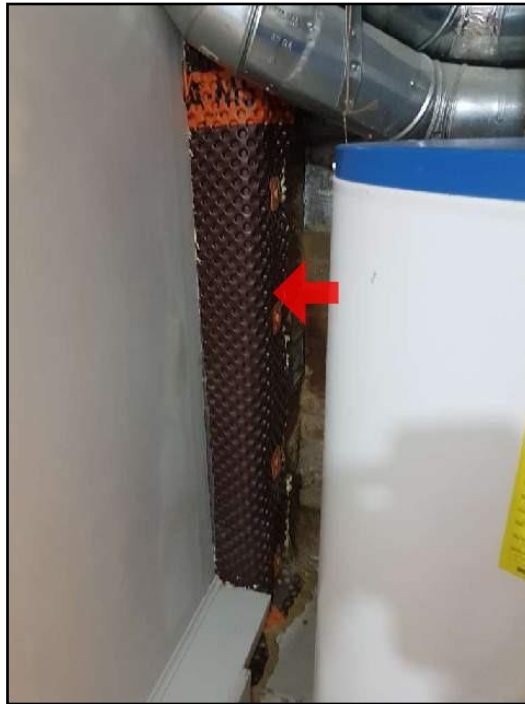
14. Condition: • Interior drainage membrane.

Interior membrane protects east wall from leakage. Balance of finishes are installed away from foundation with typical dampness present at brick. Ideally this area would have been membrane protected, retrofit would be invasive and costly. Recommend venting wall to interior and dehumidifying. Monitor for need for further action.

Location: Basement

10. Interior drainage membrane.

Task: Improve
