# Your Inspection Report

75 Browning Avenue  
Toronto, ON M4K 1W1

Tuesday, October 6, 2020

RE: Report No. 3174  
75 Browning Avenue  
Toronto, ON  
M4K 1W1

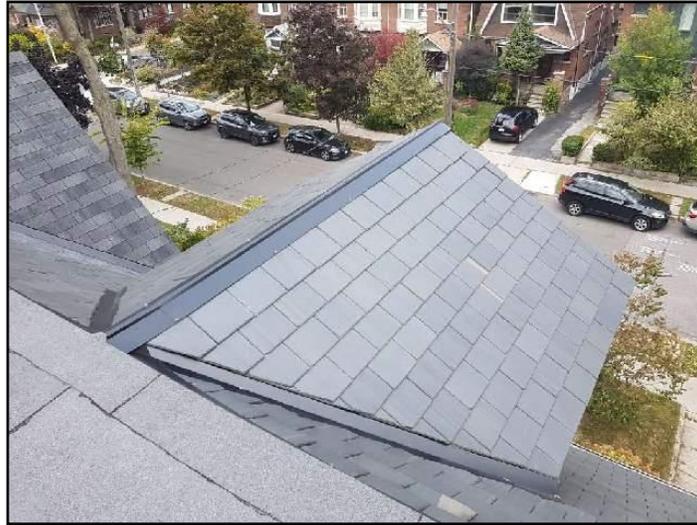
1.

Sloped roofing material: • Reproduction slate

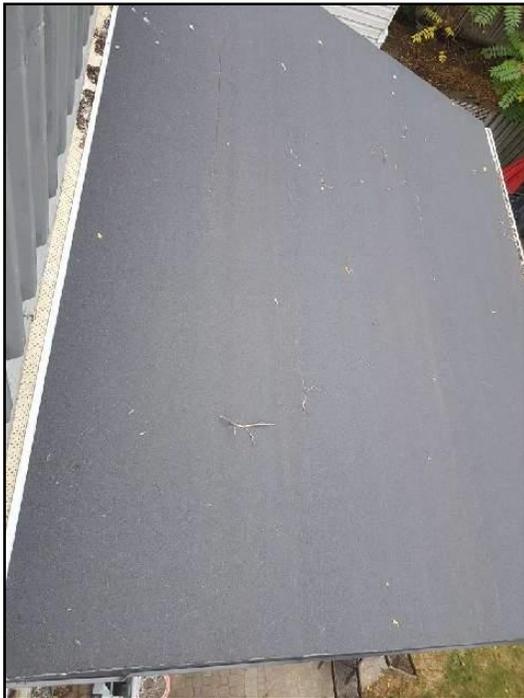
2.

• [Modified bitumen membrane](#)

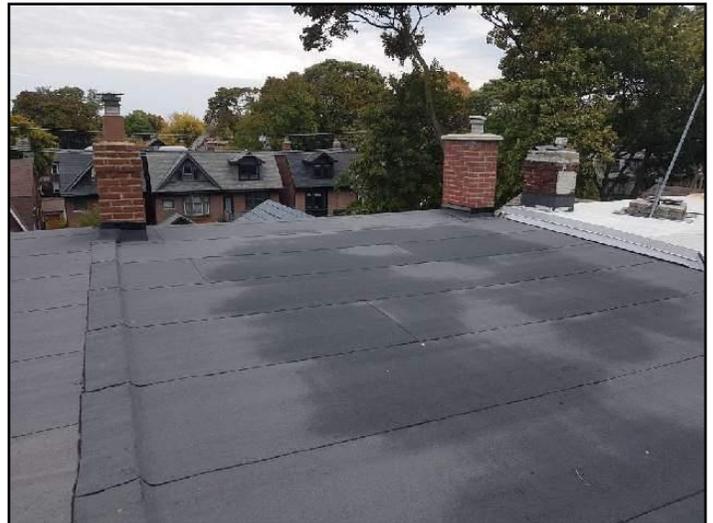
3.

**Roof inspection limited/prevented by:** • Deck, could not inspect roof membrane below.

**1. Condition:** • Inspect flat roof under balcony/deck when replaing decking. Budget \$5000, eliminate unused chimney and extend plumbing stack well above deck.

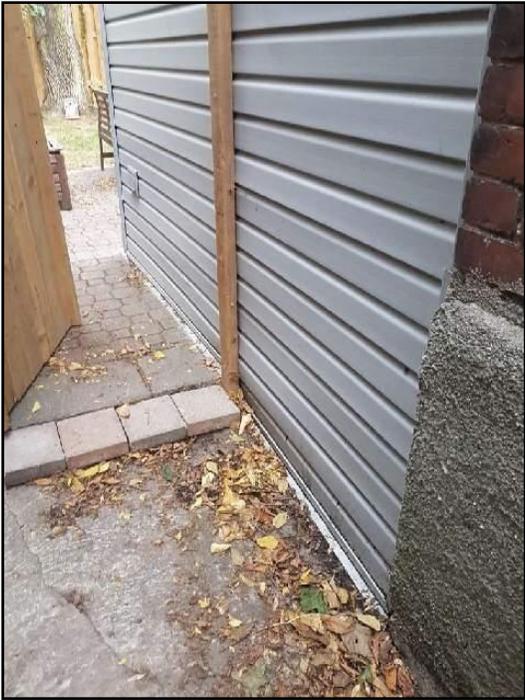
4.

**2. Condition:** • [Too close to grade](#)

Ideally siding and wood structure would terminate above grade, to prevent moisture from contacting wood structure behind siding.

**Implication(s):** Chance of water damage to structure, finishes and contents

**Task:** Improve

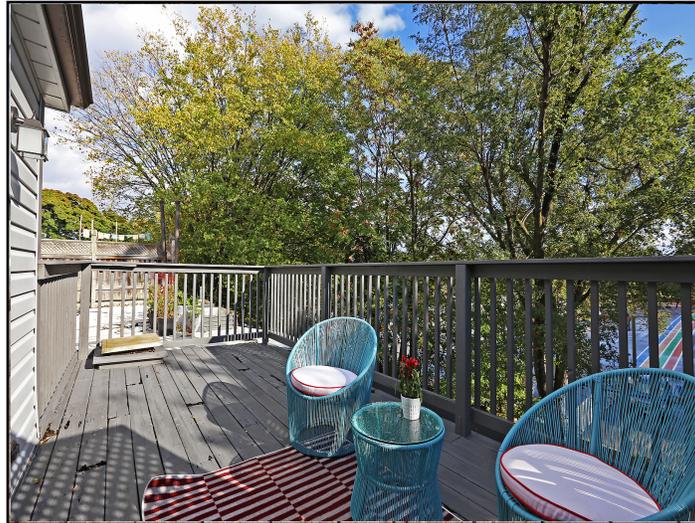
5.

3. Condition: • [Rot](#)

Balcony due for replacement. See also ROOFING.

**Implication(s):** Weakened structure | Chance of movement | Material deterioration

**Task:** Replace

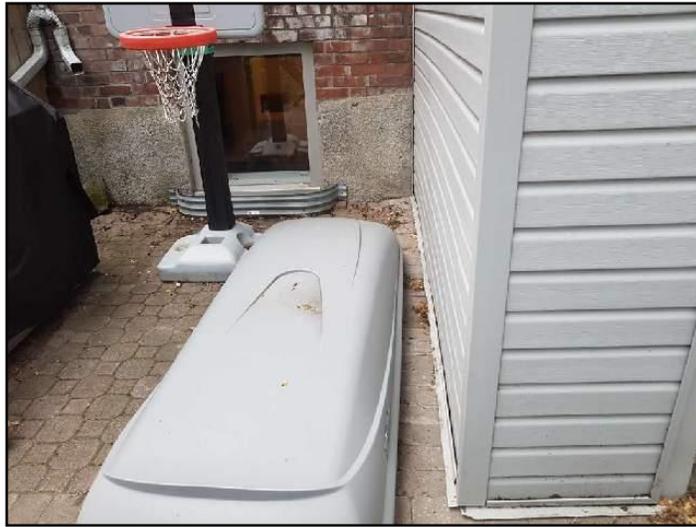
6.

4. **Condition:** • [Slope toward building](#)

**Implication(s):** Chance of water damage to structure, finishes and contents

Relay interlocking to restore drainage slope away from foundation.

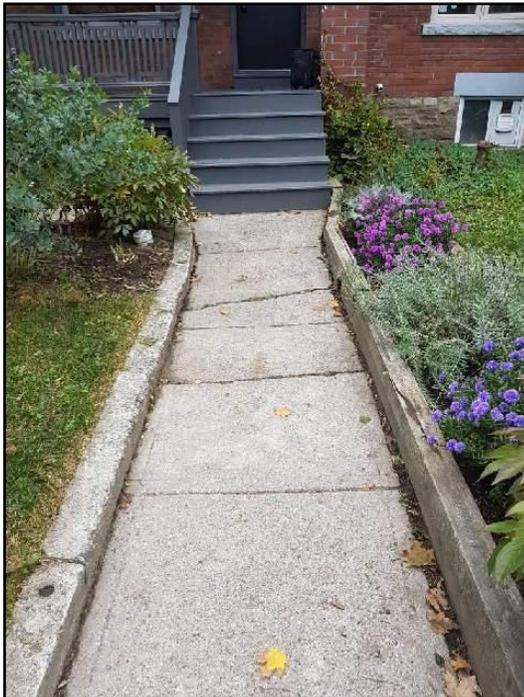
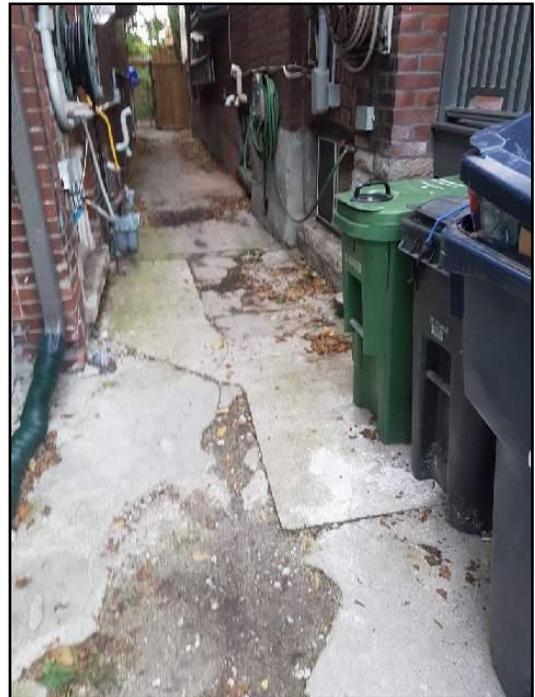
**5. Condition:** • [Cracked or damaged surfaces](#)

**Implication(s):** Trip or fall hazard

Top up or replace concrete to create drainage away from foundation and eliminate trip hazards.

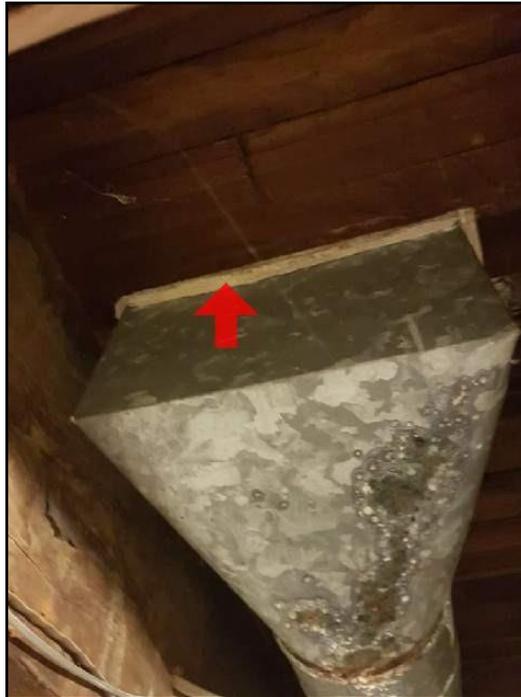
**10. Condition:** • Some asbestos present at ducting, remove if necessary to disturb.  
Typical of this era of construction, some asbestos is present around ducting. Remove only if necessary to disturb (ie if renovating).

9. Asbestos

**Task:** Remove

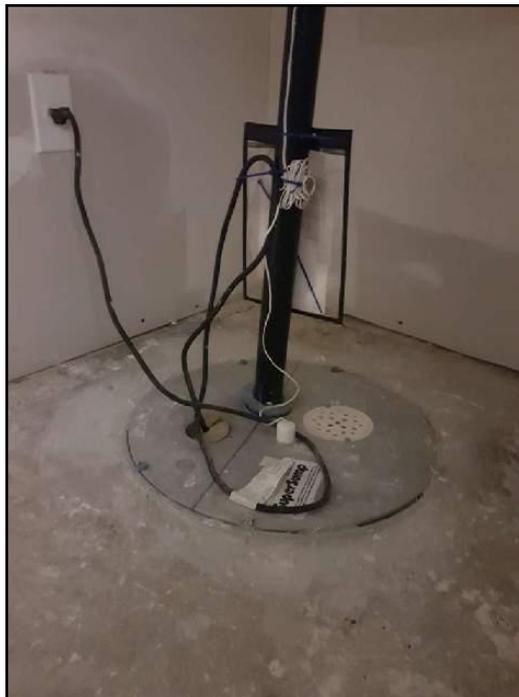
10.

• [Sump pump](#)

**14. Condition:** • Consider back up pump and battery back up at sump system.  
Insurance company may request back up system for pump.

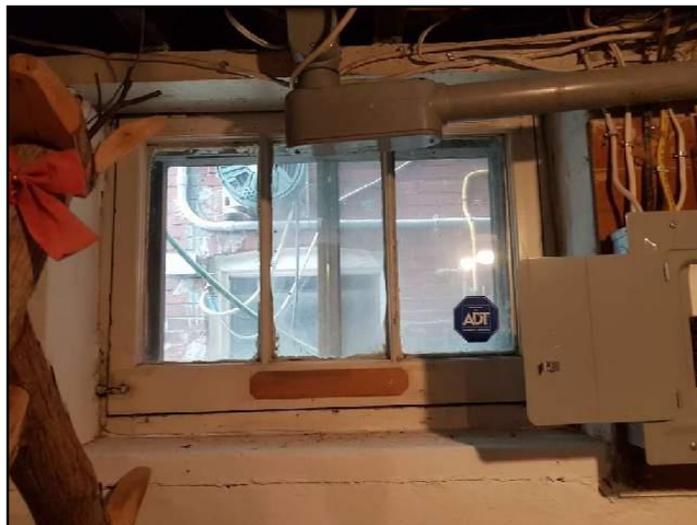
11.

**15. Condition:** • [Original lower quality units](#)  
**Implication(s):** Increased heating costs | Increased maintenance costs  
**Location:** Basement and middle second floor  
**Task:** Replace  
**Time:** Discretionary  
**Cost:** Consult contractor for cost
