Your Inspection Report

41 Hazelwood Avenue
Toronto, ON M4J 1K4

Tuesday, December 8, 2020

RE: Report No. 3218
41 Hazelwood Avenue
Toronto, ON
M4J 1K4

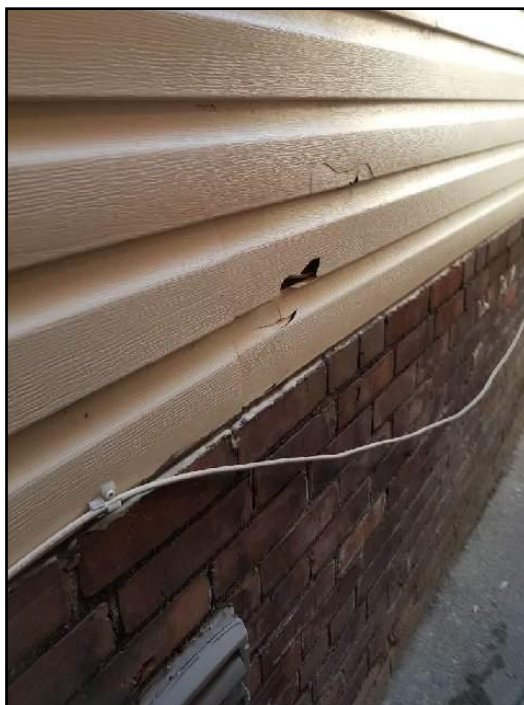
3.

2. Condition: • [Mechanical damage](#)

Repair damaged siding and add flashing at transition to foundation.

Implication(s): Chance of water damage to structure, finishes and contents

Location: West Exterior Wall

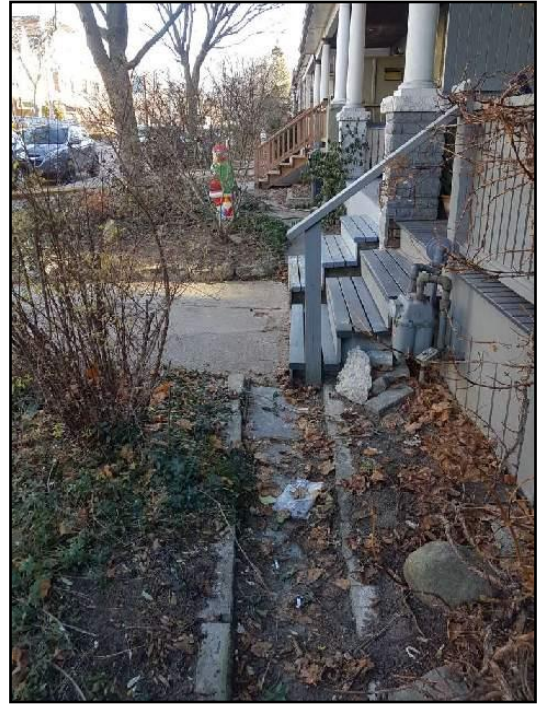
5.

4. Condition: • [Improper slope or drainage](#)

Create drainage slope away from foundation at front and side walkways.

Location: Various Exterior

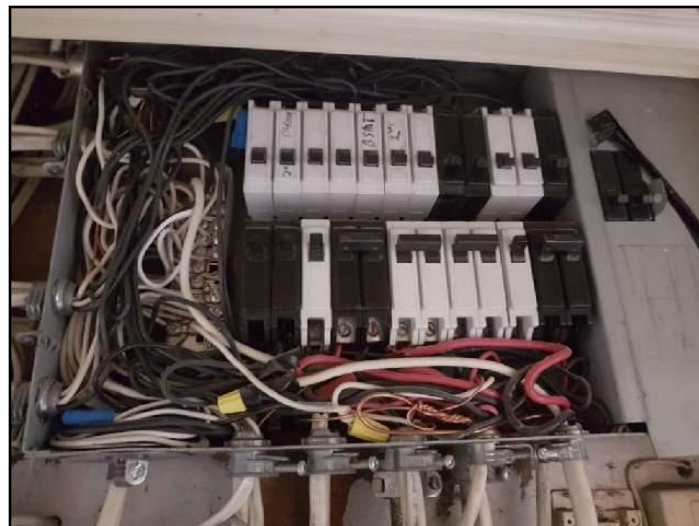
6.

10. Condition: • [Crowded](#)

24 circuit basement panel has several multi taps and should be replaced with larger panel (or add auxillary panel beside existing). Consider upgrade to 200 amps.

Implication(s): Electric shock | Fire hazard

Location: Basement

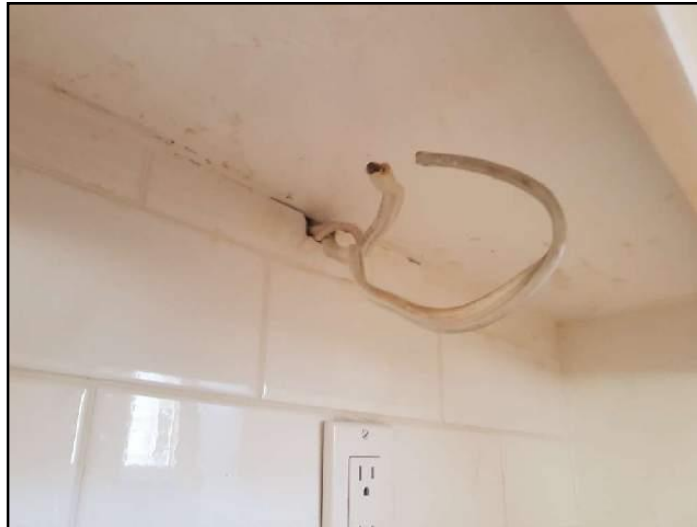
7.

11. Condition: • [Abandoned wire](#)

Cap unused wiring in junction box.

Location: First Floor Kitchen

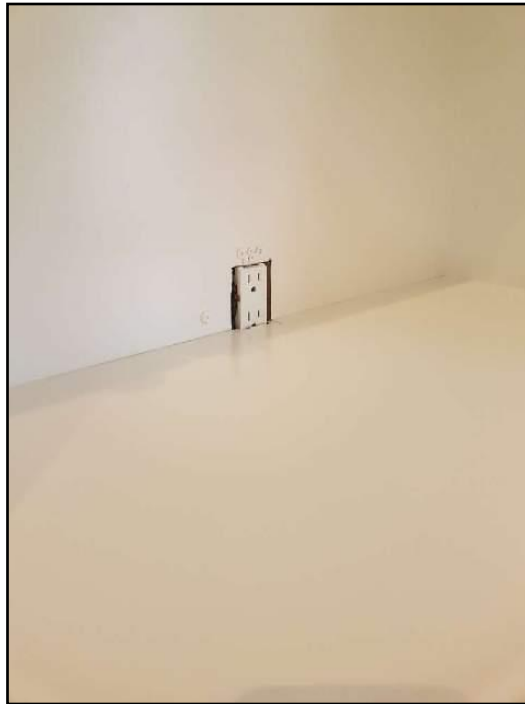
8.

14. Condition: • [Missing](#)

Cut shelf to allow for coverplate.

Location: Various

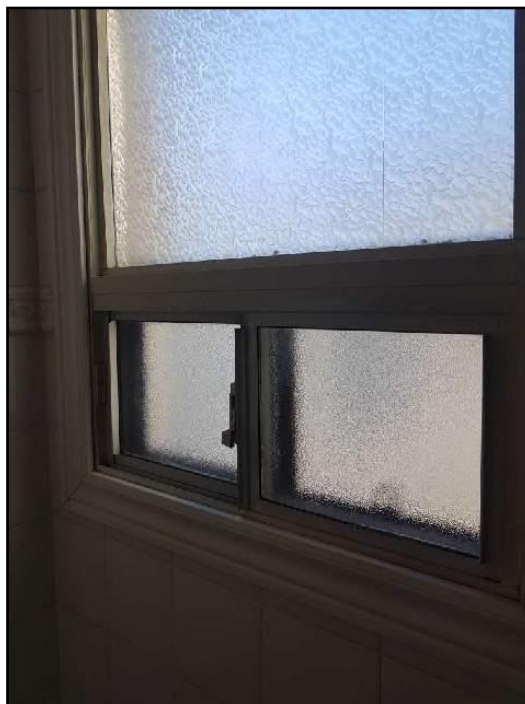
9.

23. Condition: • [Unprotected window](#)

Protect window with shower curtain.

Location: Second Floor Bathroom

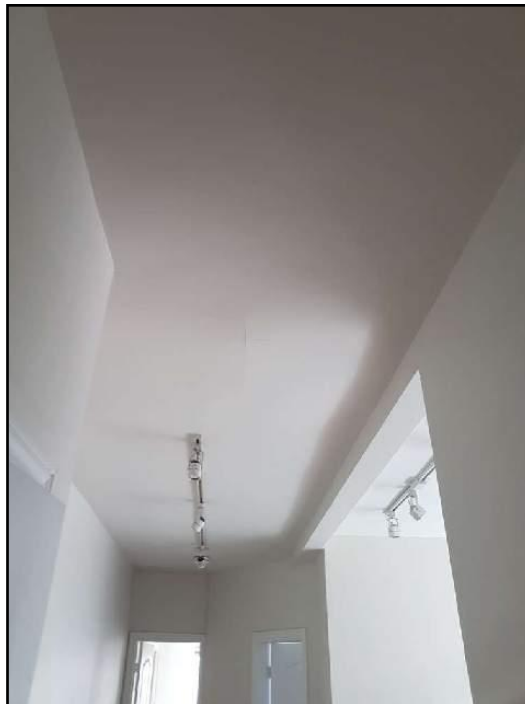
10.

25. **Condition:** • [Sag](#)

Loose drywall/plaster at second floor hallway has potential to fall.

Location: Second Floor Hall

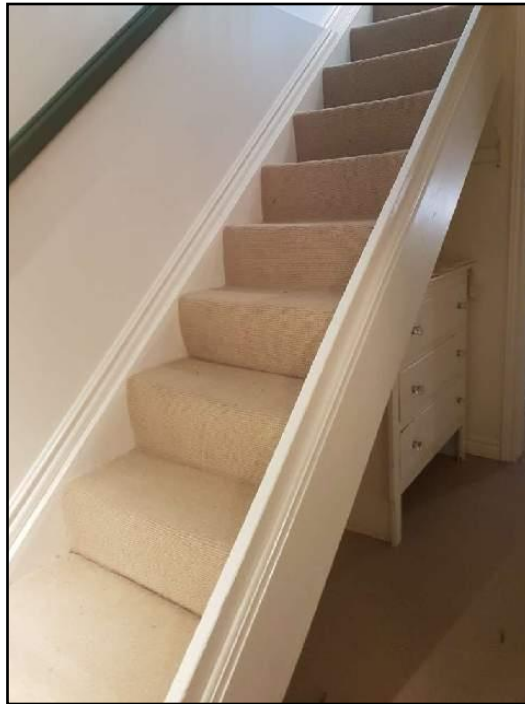
11.

26. Condition: • [Missing](#)

Implication(s): Fall hazard
Location: Basement Staircase
Task: Provide
Time: Immediate
Cost: Minor

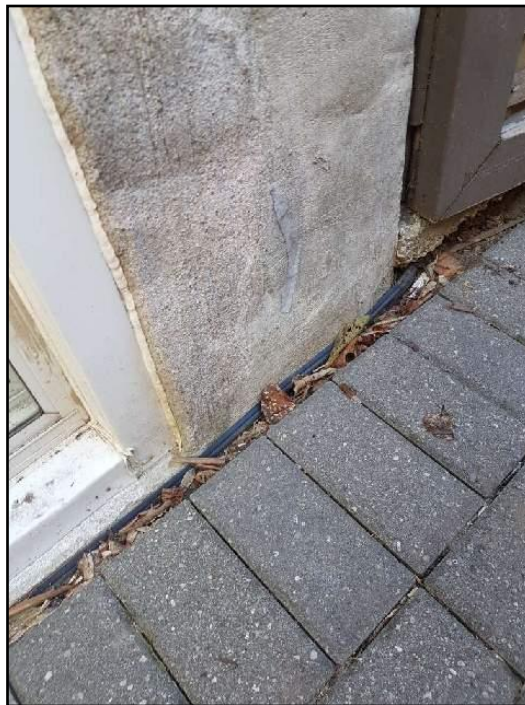
12.

27. Condition: • [Drainage membrane](#)

Exterior foundation membrane visible only at s/w exterior. Improve surface drainage as outlined in EXTERIOR to prevent moisture entry. Typical efflorescence visible at furnace room.
