Your Inspection Report

105 Boulton Avenue
Toronto, ON M4J 1B2

Wednesday, July 14, 2021

RE: Report No. 3407
105 Boulton Avenue
Toronto, ON
M4J 1B2

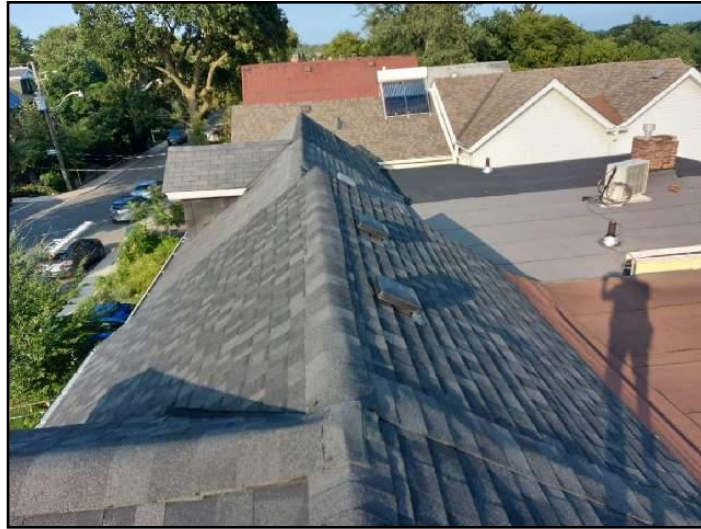
1.

- [Asphalt shingles](#)

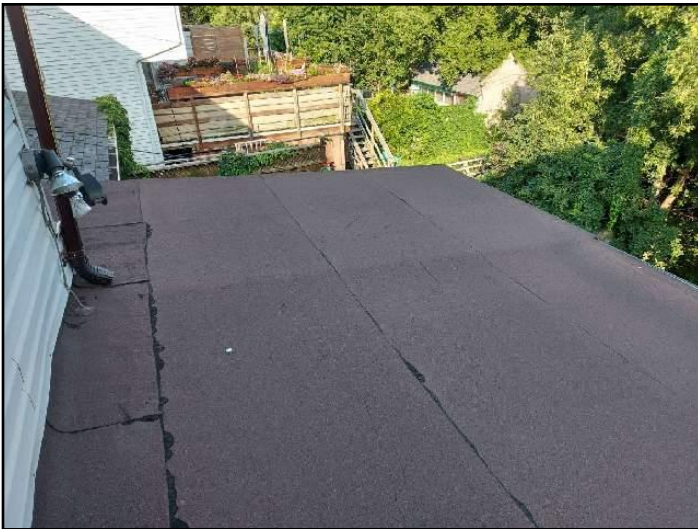
2.

- [Modified bitumen membrane](#)

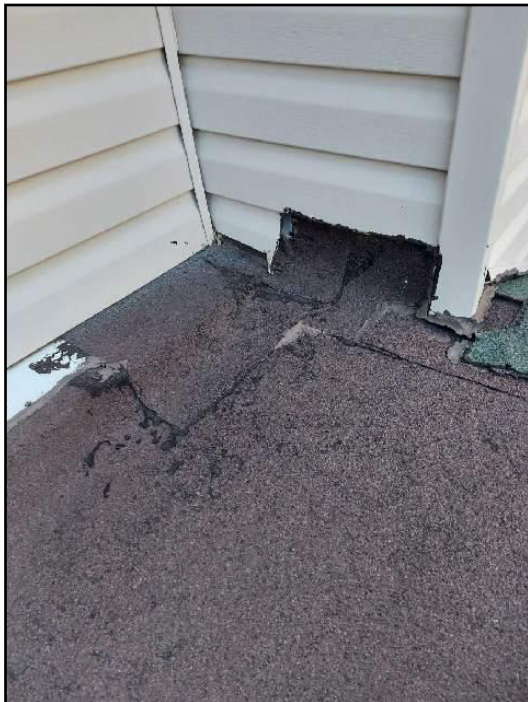
1. **Condition:** • [Open at seams or ends](#)

Tune up needed at flat roof.

4. Missing flashing

Task: Repair

**SELLER WILL AGREE TO ROOF REPAIRS
TO FLAT PORTION**

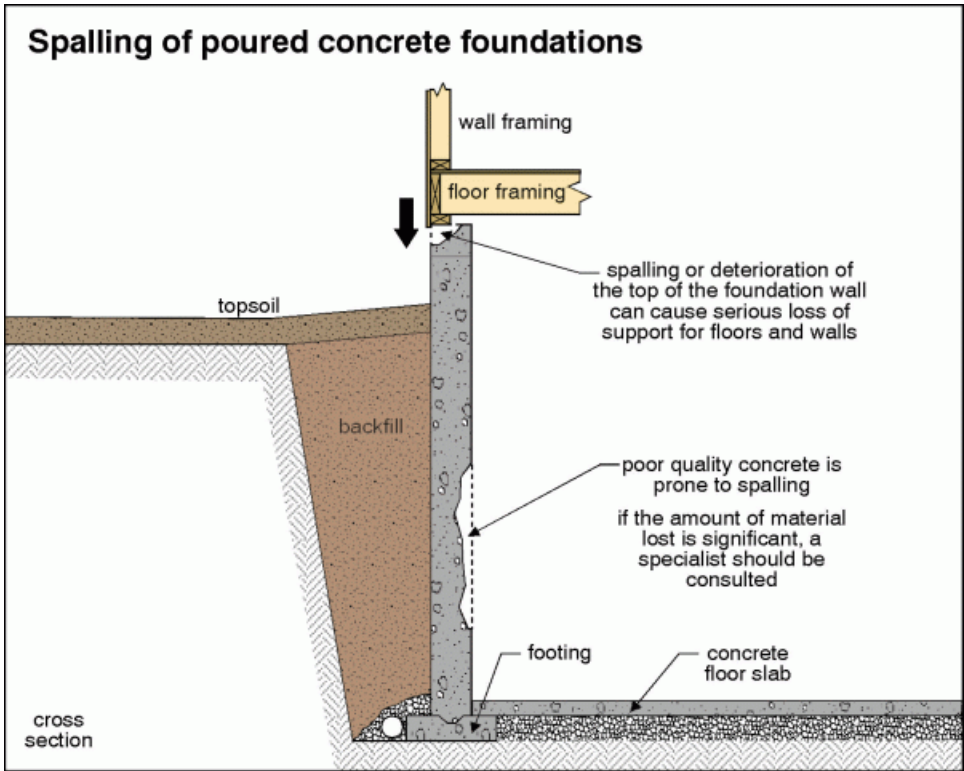
5. Condition: • [Spalling, crumbling or broken material](#)

Typical in concrete of this era, pare any areas exposed by future renovations.

Implication(s): Weakened structure | Chance of structural movement

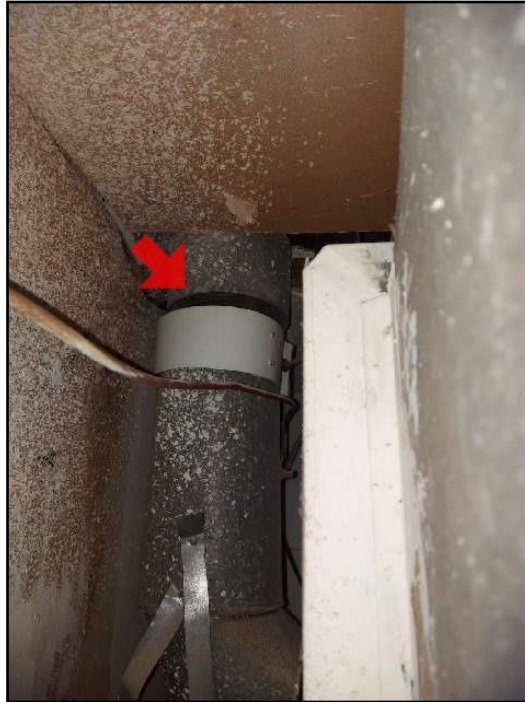
9.

FURNACE \ Ducts, registers and grilles
7. Condition: • [Leaky joints](#)
Implication(s): Increased heating costs | Reduced comfort
Location: Basement Furnace Room
Task: Repair
Time: Discretionary
Cost: Minor

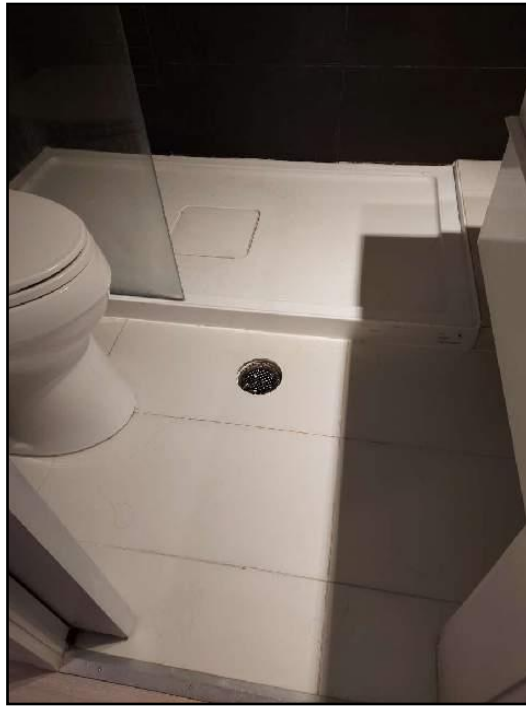
10.

11. Condition: • Trap at floor drain is not visible. If odours are noticed contact qualified plumber to retrofit. Also recommend installation of backwater valve.
