# Your Inspection Report

78 Winnifred Avenue  
Toronto, ON M4M 2X3

Thursday, September 2, 2021

RE: Report No. 3421  
78 Winnifred Avenue  
Toronto, ON  
M4M 2X3

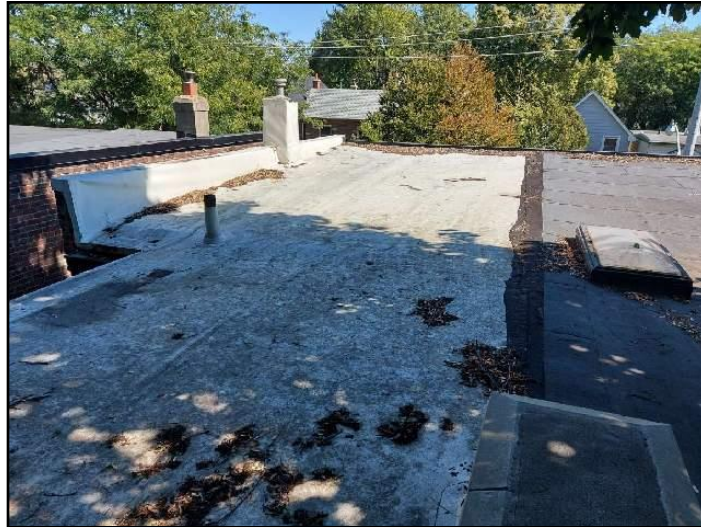
• [Plastic single ply](#)

1. **Condition:** • Seal joint over party wall with roofing cement.

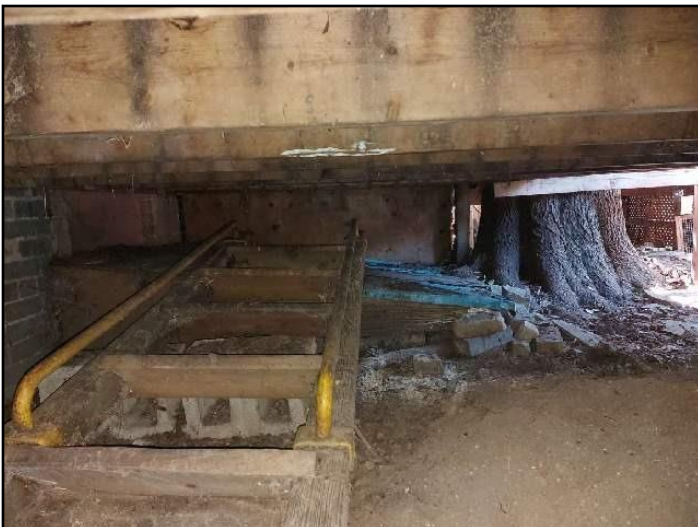
3.

#### **2. Condition:** • [Cover inoperable](#)

Abandoned walkout from basement will require eventual removal or replacement. Very large tree and age have damaged retaining walls (not accessed, reported by vendor). Before finishing basement or when replacing back deck this issue should be addressed.

**Implication(s):** Walkout unusable

**Location:** Southwest Exterior

**Task:** Replace Further evaluation

**AGENT'S NOTE:** Homeowner has covered area and applied Blueskin. No water penetration has occurred. Opening could be re-purposed as large window well if buyer chooses to alter.

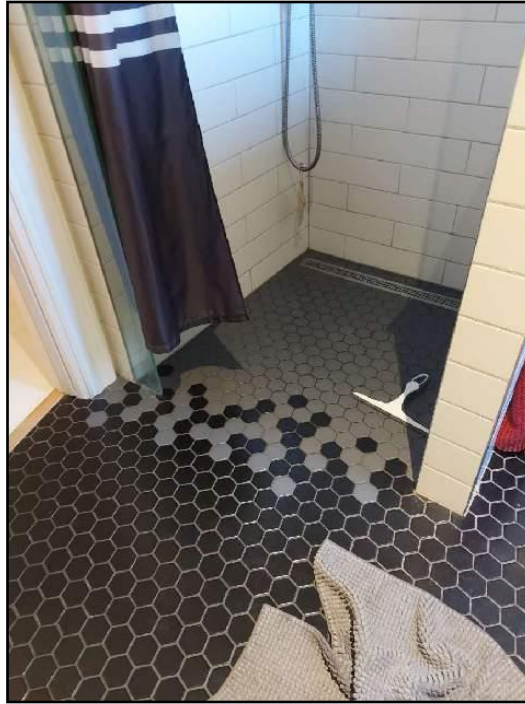
6.

**8. Condition:** • [Sill and threshold problems](#)

Add sill strip at entrance to shower.

**Implication(s):** Chance of water damage to structure, finishes and contents

**Location:** Second Floor Bathroom

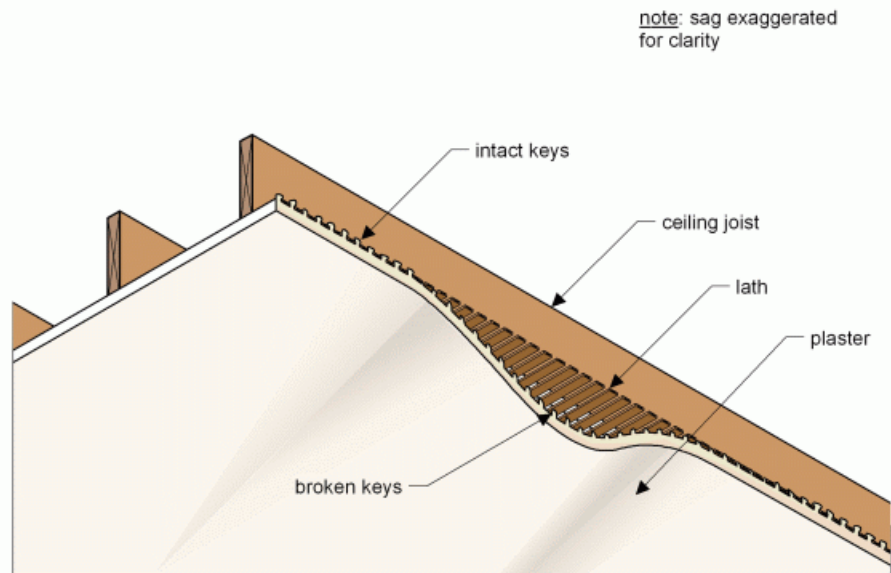
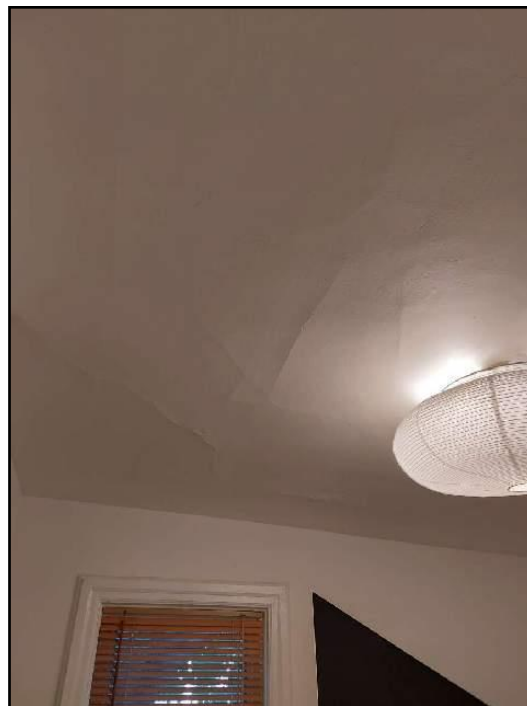
7.

9. Condition: • [Sag](#)

Plaster in poor condition at west bedroom ceiling. Recommend replacement.

Implication(s): Chance of movement

Location: West Second Floor Bedroom

## Sagging ceilings - broken keys

Task: Replace

AGENT'S NOTE: De-lamination of areas of plaster has been repaired.

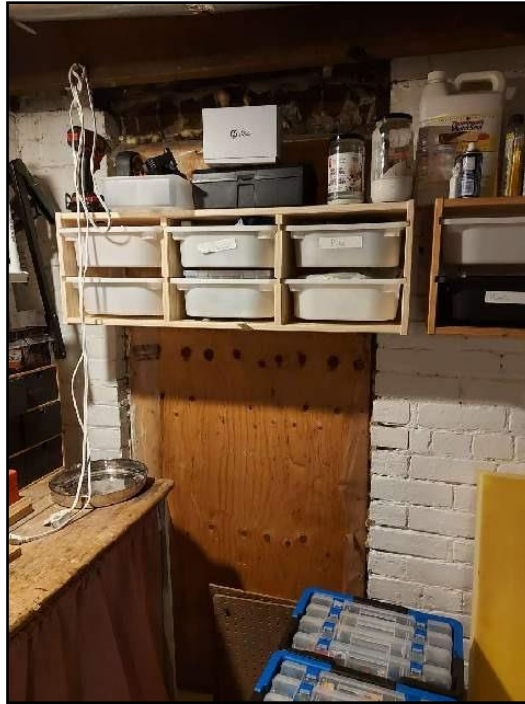
10. **Condition:** • Door to abandoned basement walkout vulnerable to leakage. (See EXTERIOR).

**Location:** Southwest Basement

8. Interior view

**Task:** Further evaluation
