# Your Inspection Report

1245 Queen Street East  
Toronto, ON M4L 1C2

RE: Report No. 3557  
1245 Queen Street East  
Toronto, ON  
M4L 1C2

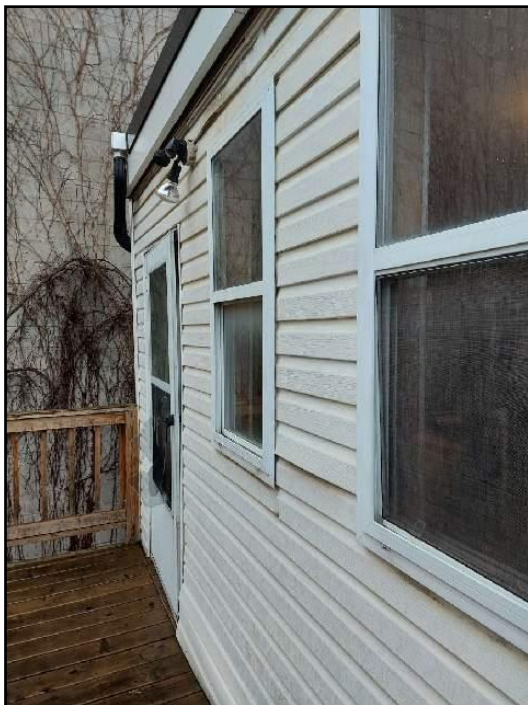
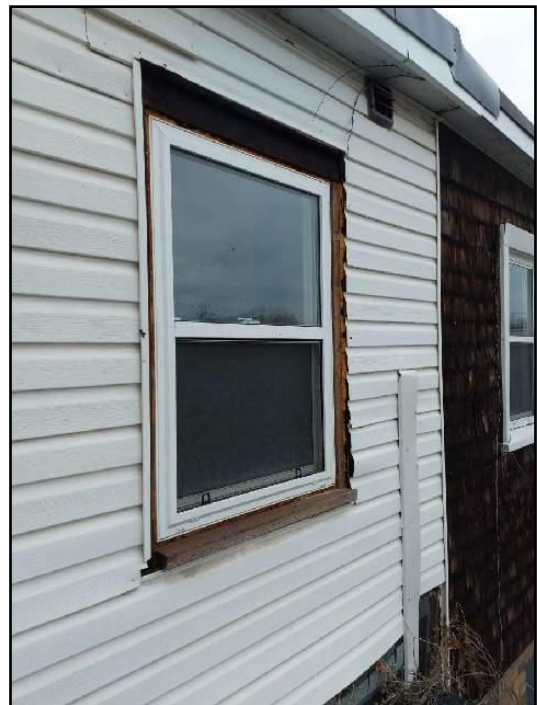
2. Condition: • [Loose or missing pieces](#)

Poorly installed vinyl siding should be replaced.

**Implication(s):** Chance of water damage to structure, finishes and contents

**Location:** South Exterior

**Task:** Replace

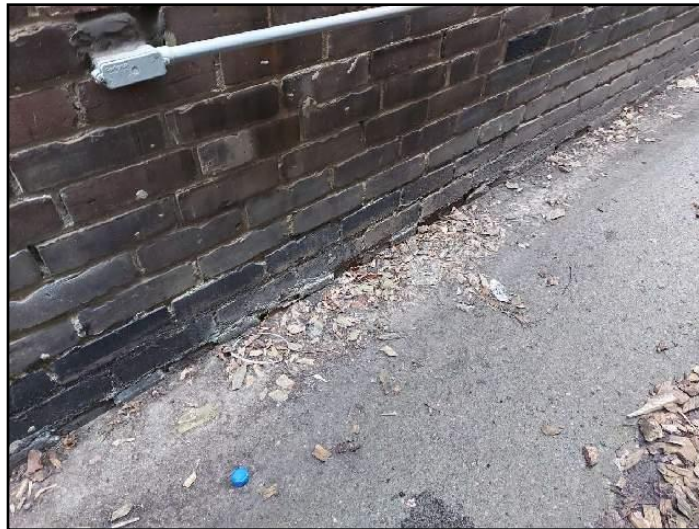
6.

### 3. Condition: • [Parging damaged or missing](#)

Typical minor parging and tuckpointing needed.

**Implication(s):** Chance of damage to structure | Shortened life expectancy of material

**Location:** Various Exterior Wall

**Task:** Repair

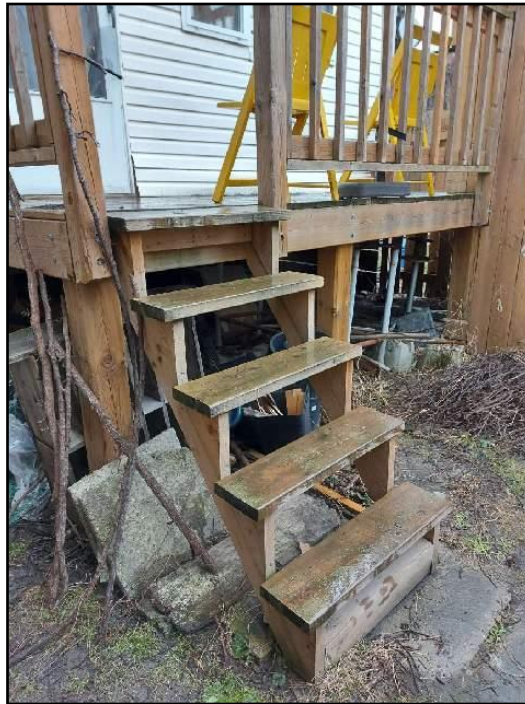
7.

### 5. Condition: • Trip hazard

Replace steep steps (stringers installed upside down) and add handrail.

**Implication(s):** Trip or fall hazard

**Location:** South Deck

**Task:** Improve

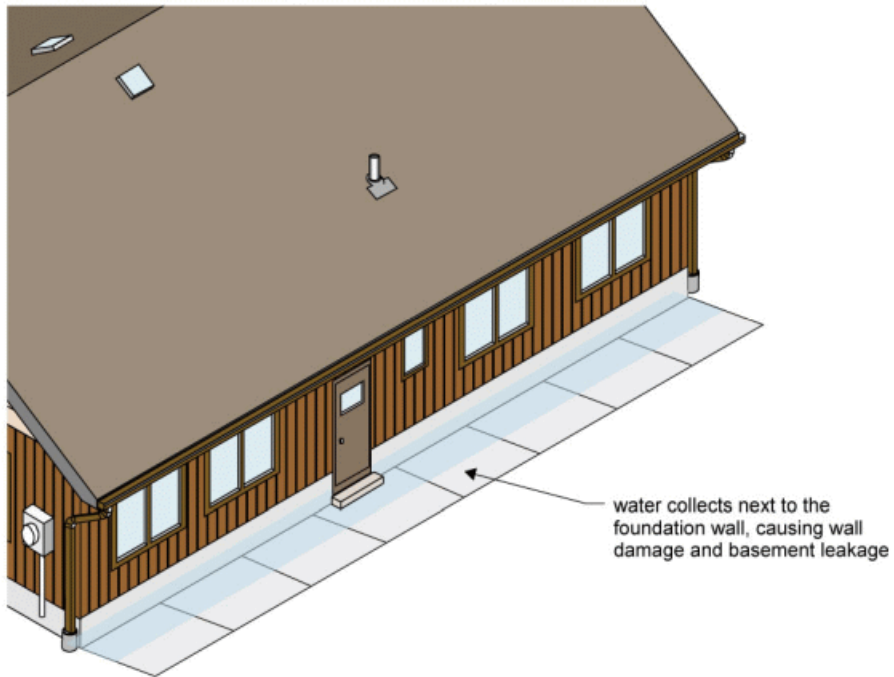
### **6. Condition:** • [Improper slope or drainage](#)

**Implication(s):** Chance of water damage to structure, finishes and contents

Walk/patio sloping towards house

Add concrete over existing to create drainage away from foundation.

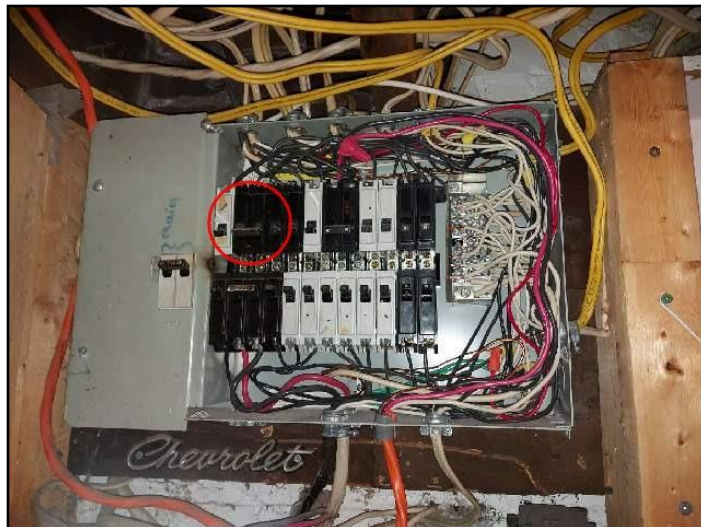
8.

**9. Condition:** • Oversized breaker (breaker too big).  
Replace oversized 20 amp breaker.  
**Location:** Basement Panel  
**Task:** Replace  
**Time:** Immediate  
**Cost:** Minor

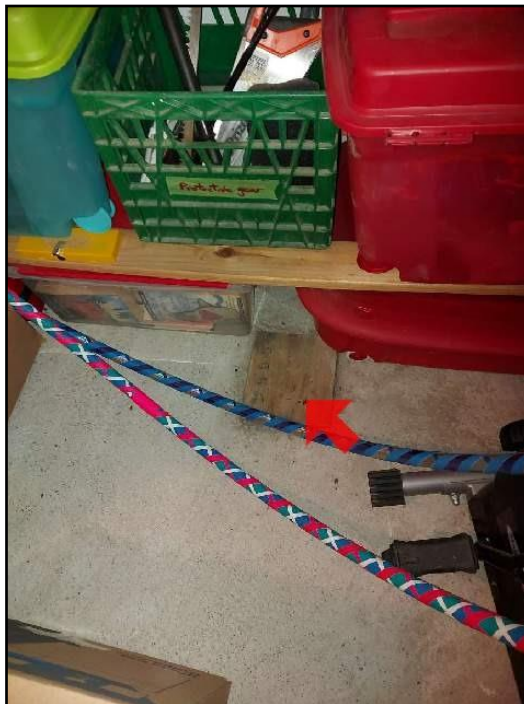
9.

**13. Condition:** • [Obstructed](#)

Apparent floor drain is full of gravel, could not determine if this drain is functioning. If repair is needed, recommend adding backwater valve.

**Implication(s):** Chance of water damage

**Location:** North Basement

**Task:** Clean and further evaluate

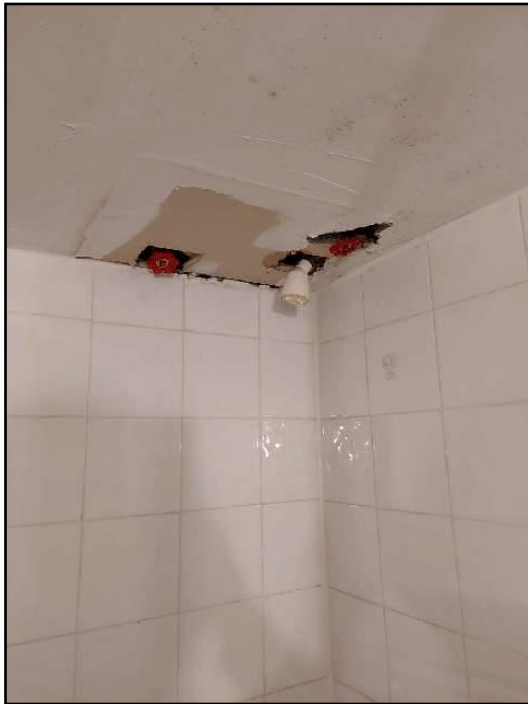
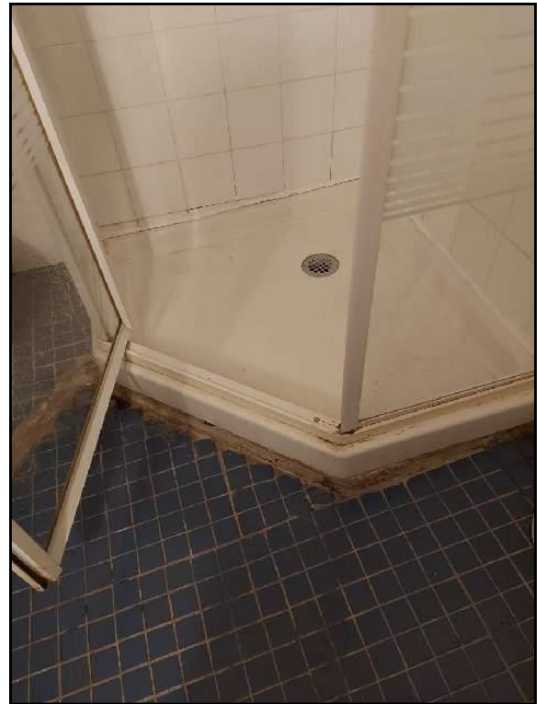
**15. Condition:** • Faucets in awkward location, door difficult to close at basement shower stall.

**Location:** Basement

**Task:** Replace

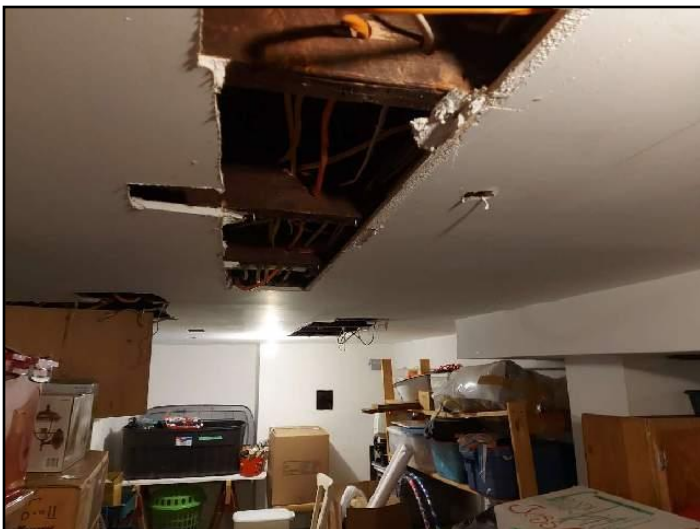
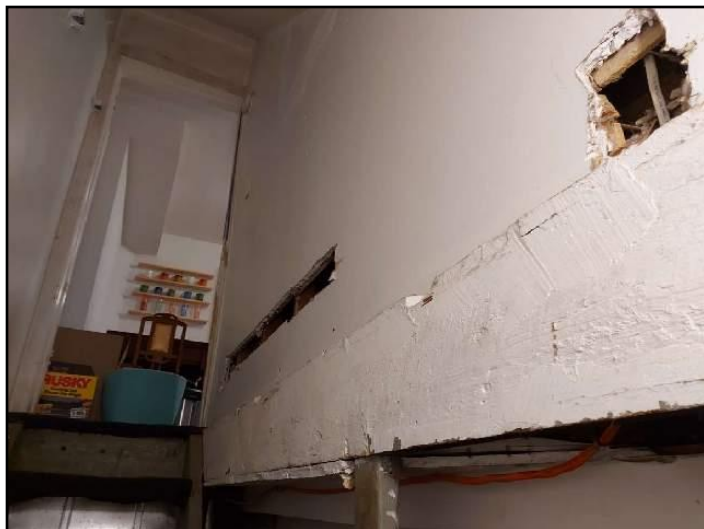
18. **Condition:** • Drywall repairs needed at basement where access created for rewiring.

**Location:** Basement

**Task:** Repair

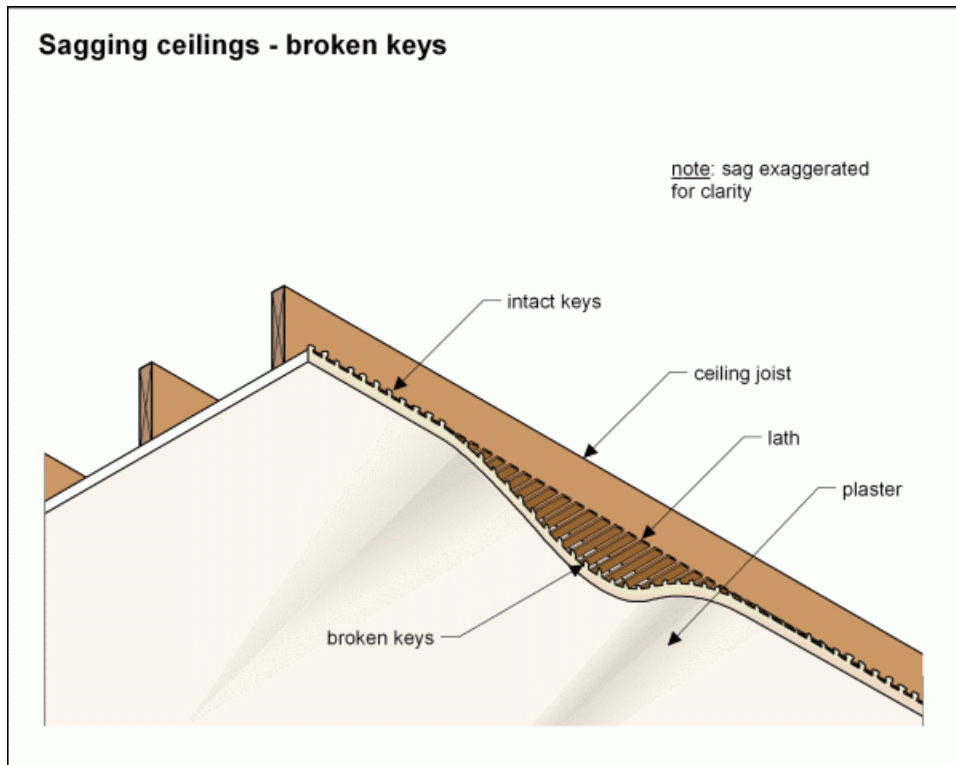
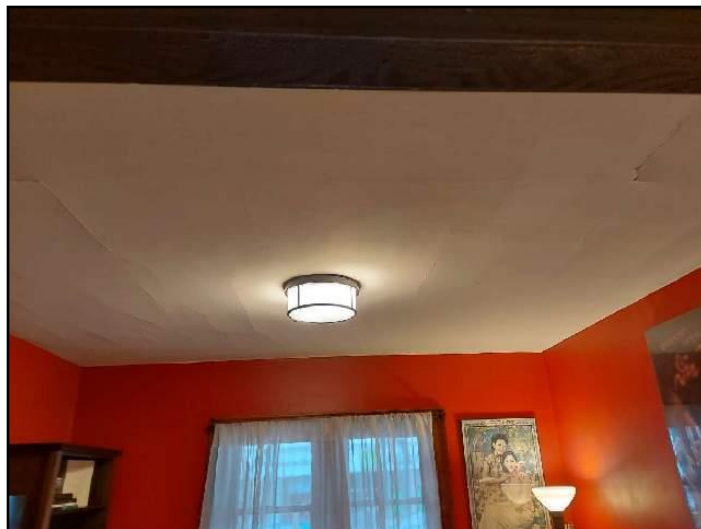
14.

### 19. Condition: • [Sag](#)

Living room ceiling in poor condition and will require eventual replacement.

**Implication(s):** Chance of movement

**Location:** First Floor Living Room

**Task:** Replace

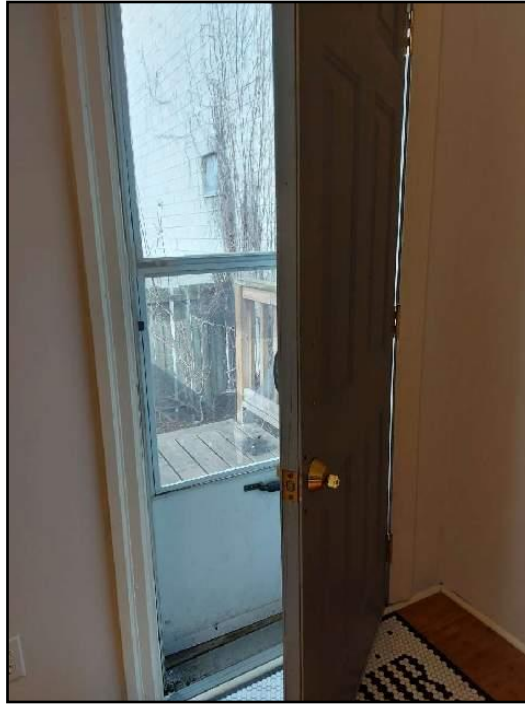
16.

**21. Condition:** • Replace poor hardware and damaged screen.

**Location:** South First Floor

**Task:** Replace

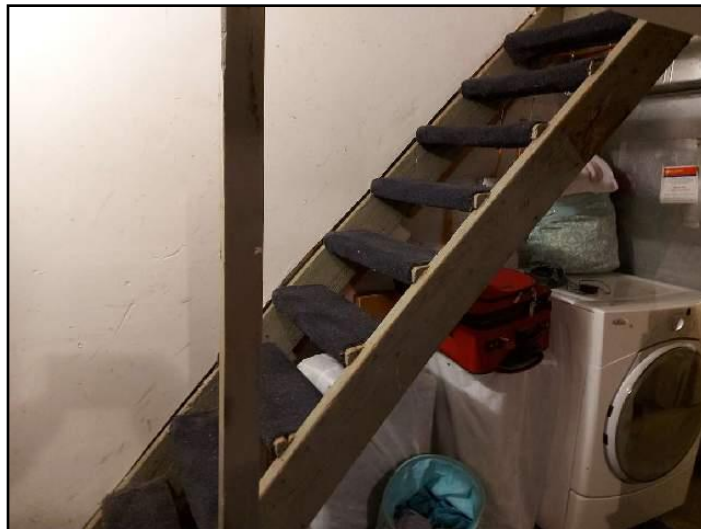
17.

**22. Condition:** • [Missing](#)

**Implication(s):** Fall hazard

**Location:** Basement Staircase

**Task:** Provide
