# **Your Inspection Report**

## 308 St George St Toronto, ON M5R 2P5

**PREPARED BY:** Jim Gibson, P.Eng.

RE: Report No. 74041 308 St George St Toronto, ON M5R 2P5

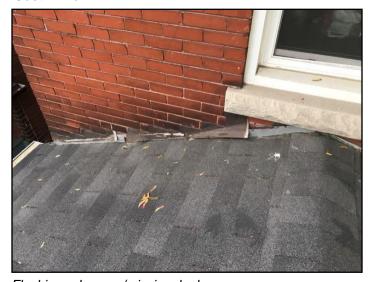
Condition: • Counter flashing - damage/missing, leak

Flashing - damage/missing, leak

Task: Repair
Time: Immediate
Cost: Minor

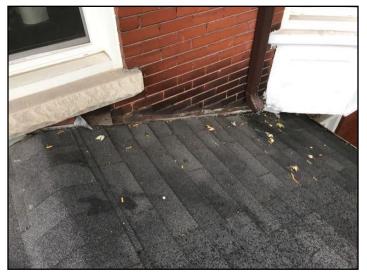
Flashing - damage/missing, leak

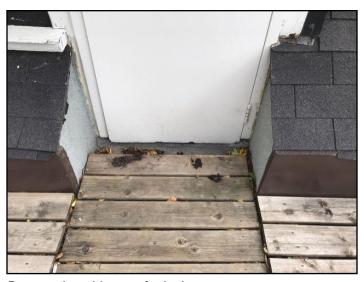
Condition: • Door - vulnerable area for leaks

Door - vulnerable area for leaks

**Location**: Rear third floor **Task**: Monitor/repair

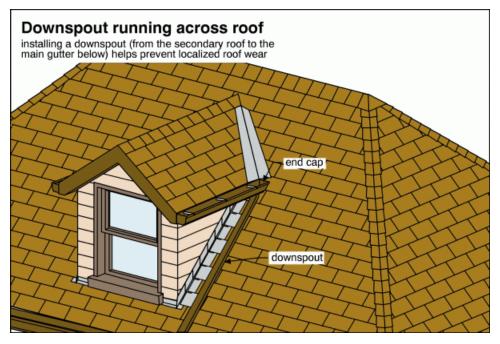
**Condition:** • Discharge onto roofs **Location**: Rear third floor dormer

Discharges onto roof

Task: Provide downspouts from upper to upper gutters

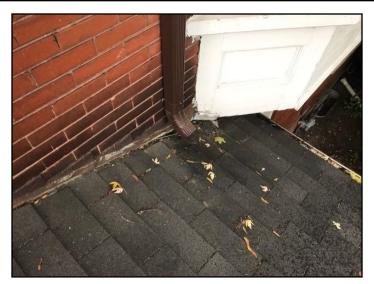
Condition: • Discharge onto roofs
Location: Front second floor
Task: Extend to lower gutter

Discharges onto roof

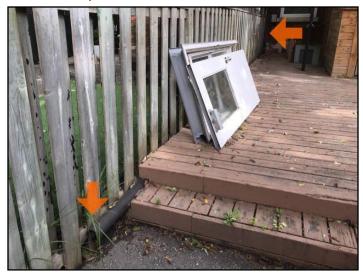
Condition: • Extension - length excessive, slope suspect

Extension - length excessive, slope suspect

Task: Discharge above deck more than 2 m past deck

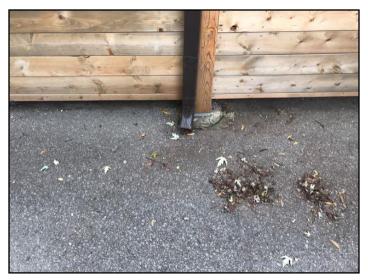
**Condition:** • Discharge location poor (onto parking pad)

Implication(s): Risk of ice/fall hazard

Discharge location poor

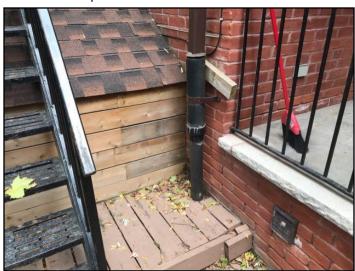
Condition: • Discharge location not visible

Discharge location not visible

Task: Discharge above grade more than 2 m past deck

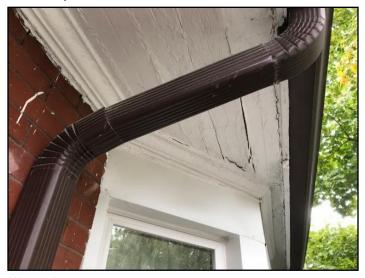
Condition: • Water/vermin damage, low quality prior repairs

Water damage

**Location**: Various second floor **Task**: Further evaluation/repair **Time**: Less than one year **Cost**: Dependent \$1500-\$3000

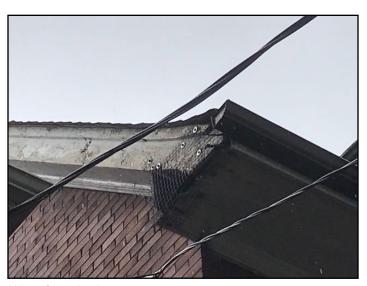
Water/vermin damage

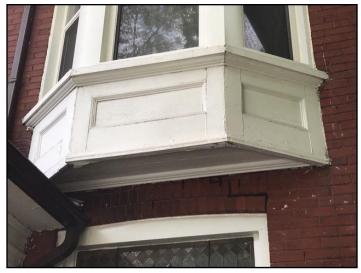
**Condition:** • Water damage Trim - incomplete/missing

Water damage

Task: Repair

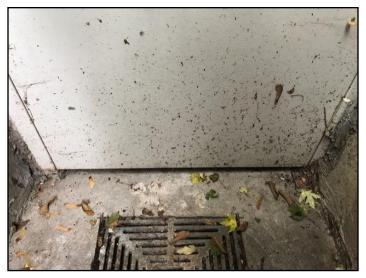
Condition: • Door - installation nonstandard (door should close over threshold)

Threshold - no clearance (above landing), slope inadequate

Threshold - clearance inadequate

Task: Monitor/repair

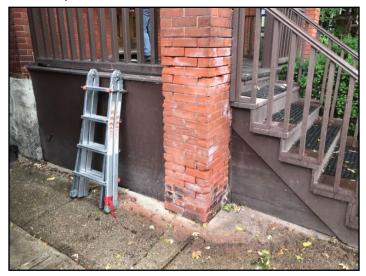
Condition: • Porch and stairs - access restricted underneath, wood/soil contact

Porch - access restricted underneath

**Task**: Further evaluation / Repair **Time**: Less than one year

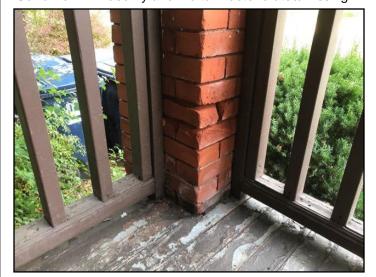
Condition: • Masonry and mortar - deteriorated/missing

Masonry and mortar - deteriorated/missing

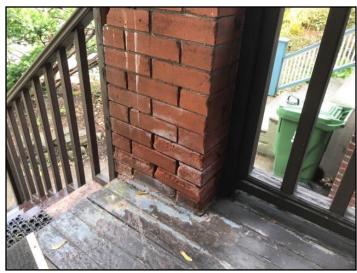
Masonry and mortar - deteriorated/missing

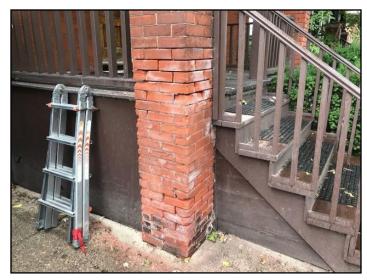
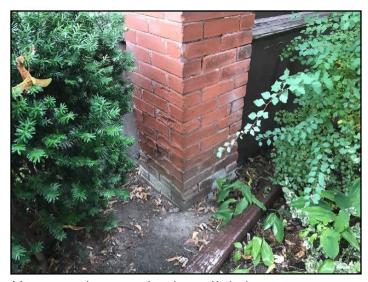
Masonry and mortar - deteriorated/missing

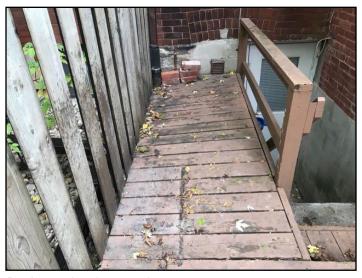
Condition: • Deck - not level, water damage

Deck - not level, water damage

Task: Further evaluation/repair

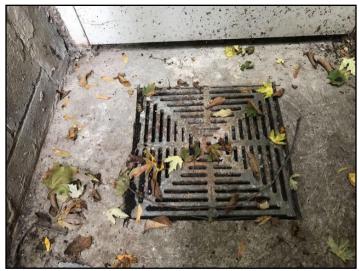
Condition: • Floor drain - vulnerable area for clogging, freezing and flooding

Floor drain - vulnerable area...

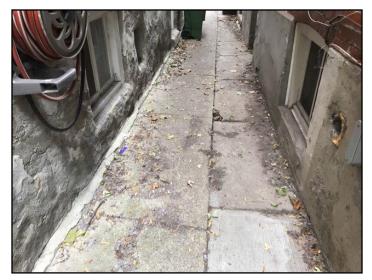
Condition: • Improper slope or drainage

Improper slope or drainage

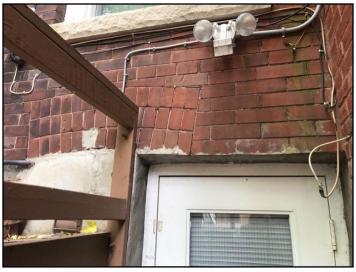
**Condition:** • Lintel - not visible/missing **Location**: Right rear basement walkout

Lintel - not visible/missing

Task: Monitor/repair

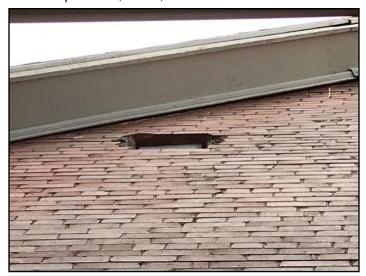
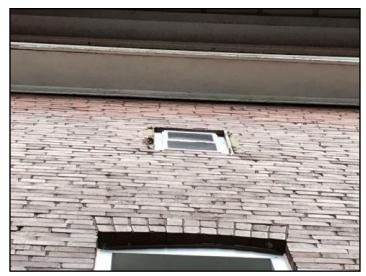
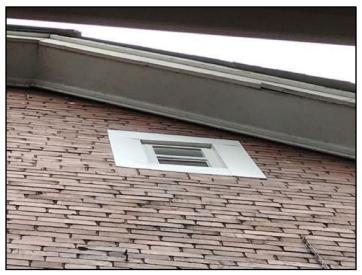
Condition: • Arches or lintels - not visible/missing

Arches or lintels - not visible/missing

Task: Monitor/repair

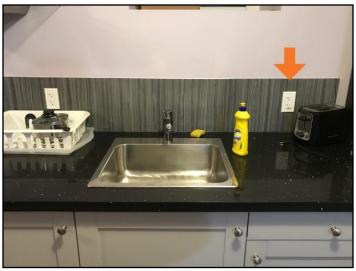
Condition: • GFCI outlet (20 amp) - redundant (on GFCI protected circuit)

GFCI outlet (20 amp) - redundant

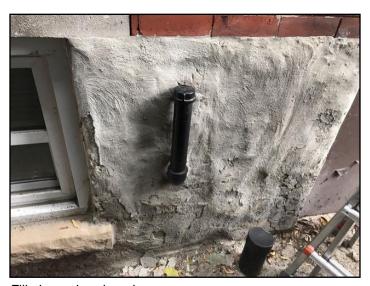
Condition: • Fuel oil tank: Fill pipe - abandoned

Fill pipe - abandoned

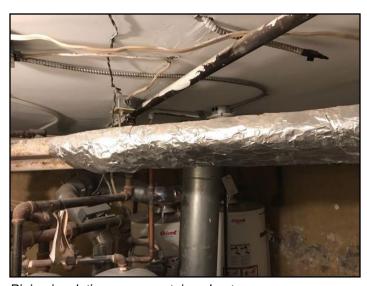
Condition: • Piping insulation - may contain asbestos

Piping insulation - may contain asbestos

**Task**: Monitor/remove **Time**: Ongoing/if necessary

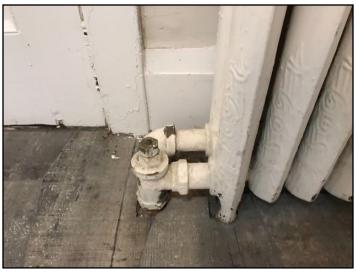
Condition: • Flow valve: Handle - damage/missing

Handle - damage/missing

**Task**: Further evaluation/replace **Time**: Less than one year/if necessary

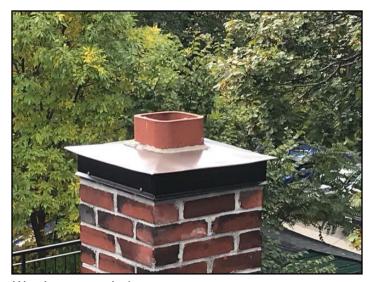
Condition: • Weather cap - missing

Weather cap - missing

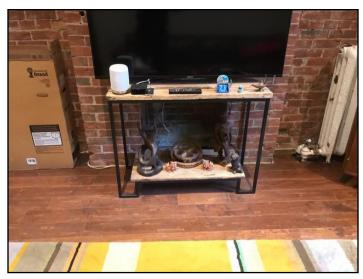
Condition: • Fireplace - nonfunctional

Hearth and firebox - missing Damper and Flue liner- not visible HEATING Report No. 74041

Fireplace - non-functional

Task: Further evaluation/repair

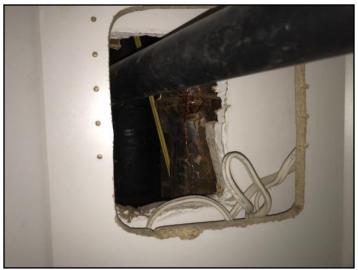
Condition: • Waste piping (cast iron) - near the end of lifespan, rust, leak suspected

Waste piping - rust, leak suspected

**Task**: Further evaluation/replace **Time**: Immediate/when necessary

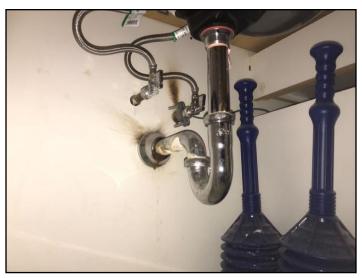
Condition: • Loose
Trap - rust, leak

Trap - rust, leak

Task: Repair/replace Time: Immediate Cost: Minor

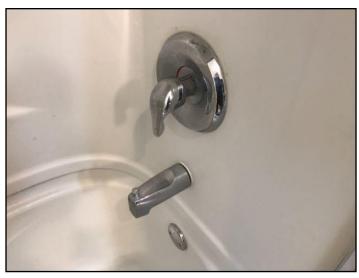
**Condition:** • Diverter - loose **Location**: Second floor bathroom

Diverter - loose

Task: Repair Time: Immediate Cost: Minor

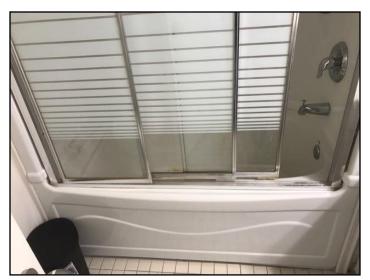
Condition: • Faucet and diverter - loose

Doors - loose

Faucet, diverter and doors - loose

Task: Repair Time: Immediate Cost: Minor

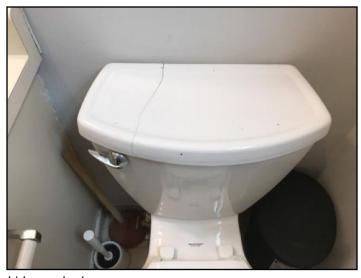
**Condition:** • Tank: Lid - cracked **Location**: Second floor bathroom

Lid - cracked

Task: Monitor/replace

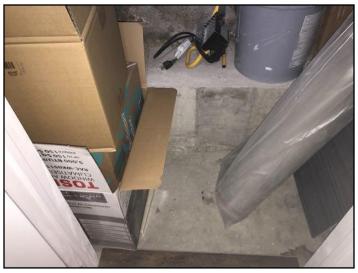
Condition: • Interior drainage system - not visible/missing (typical of older construction)

Interior drainage system - not visible...

**Location**: Various basement **Task**: Further evaluation/provide **Time**: Immediate/if necessary

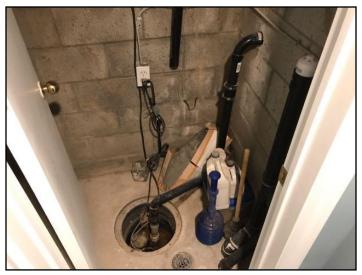
Condition: • Discharge location not visible (should discharge to exterior)

Discharge location not visible

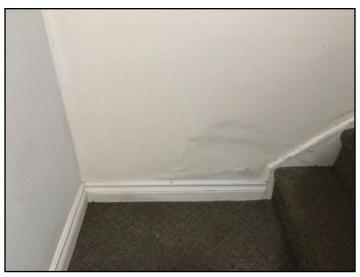
**Condition:** • Water damage **Location**: Left basement

Water damage

**Task**: Further evaluation/replace

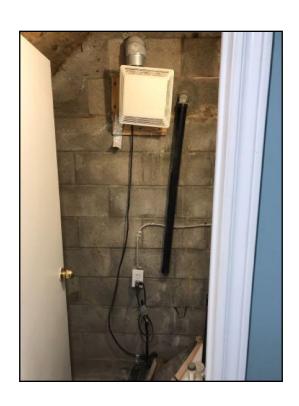
Condition: • Exhaust Fan - installation incorrect, not in service/unplugged

**Location**: Rear basement bath closet **Task**: Further evaluation/repair

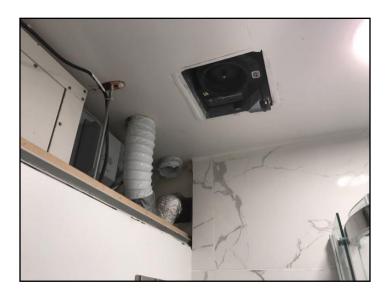
**Condition:** • Cover - missing Duct - low quality, connections poor

Task: Repair/upgrade Time: Immediate Cost: Minor

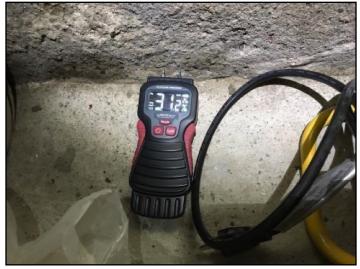
Condition: • Dampness, efflorescence, water stains/damage

Dampness, efflorescence, water stains

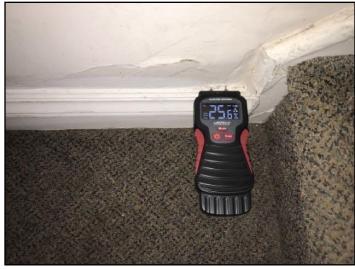
Dampness, water stains/damage

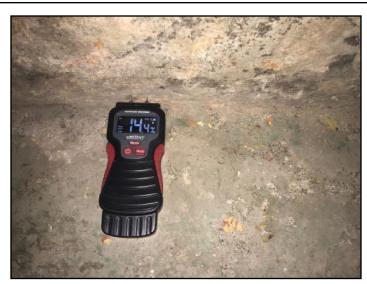
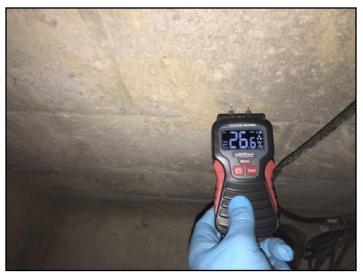
Dampness, efflorescence, water stains
