Your Inspection Report

18 Louvain Avenue
Toronto, ON M4M 1N9

Wednesday, May 18, 2022

RE: Report No. 3605
18 Louvain Avenue
Toronto, ON
M4M 1N9

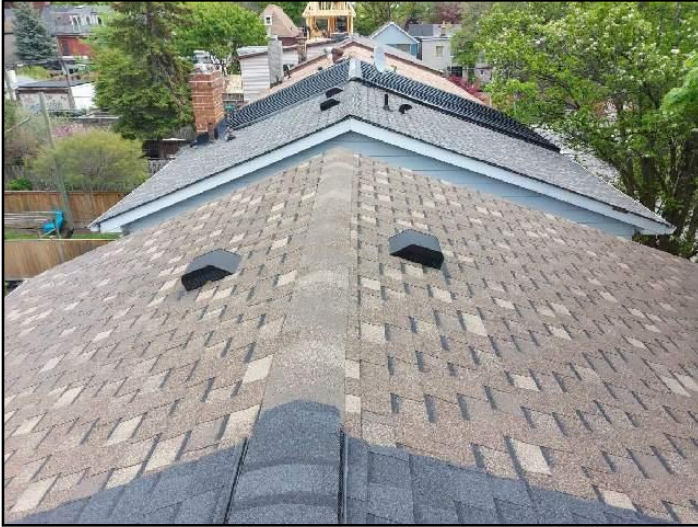
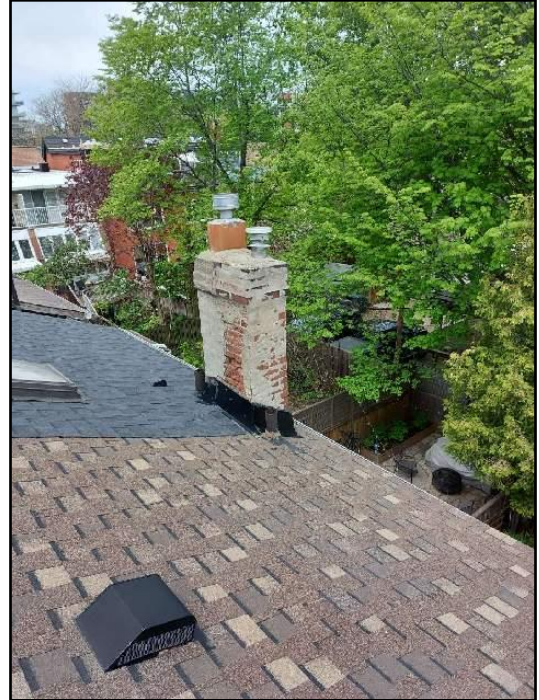
1. **Condition:** • No roofing recommendations are offered as a result of this inspection.
Roof in good condition.

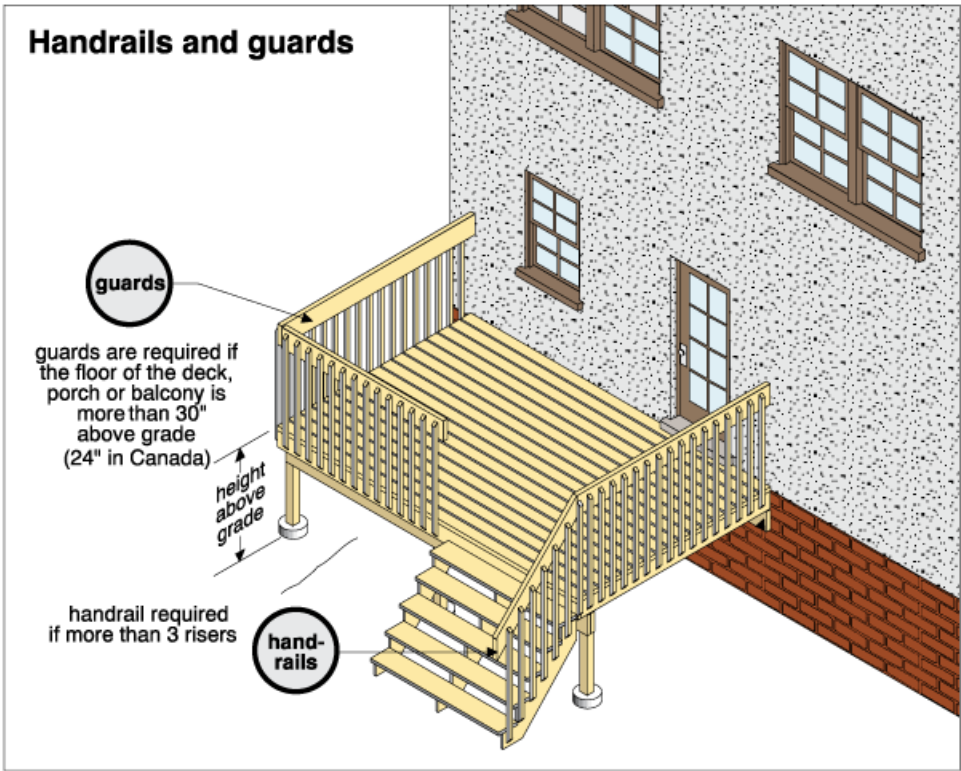
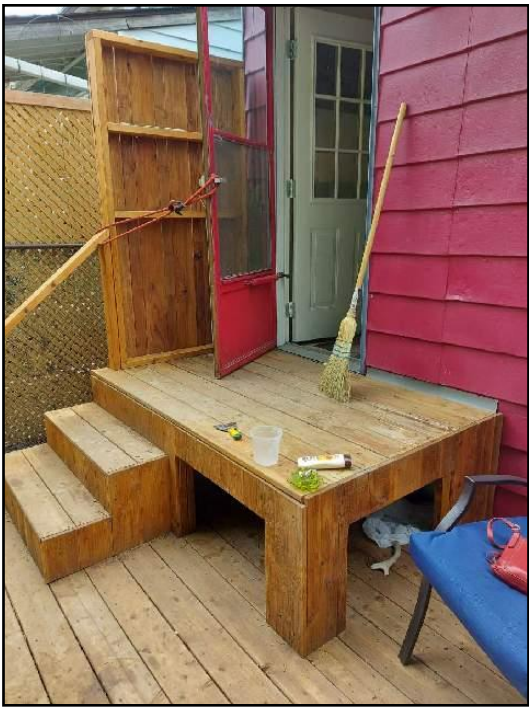
3.

2. Condition: • [Missing](#)
Add guardrail at back deck.
Implication(s): Fall hazard
Location: North Exterior Deck
Task: Provide
Time: Immediate
Cost: Minor

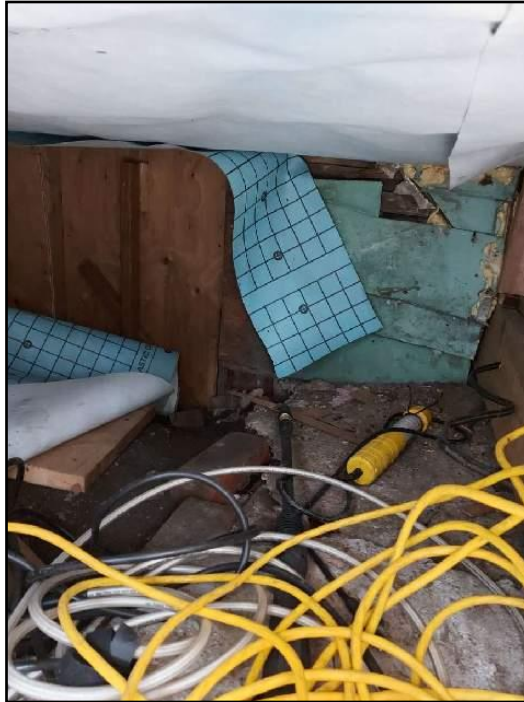
4. Condition: • No access to crawlspace

Implication(s): Potential concealed moisture problems or issues with the structure, mechanical or electrical systems, insulation, etc.

4. *View of crawlspace*

Recommend creating access to crawlspace (under kitchen) to inspect structure. Eliminate wood soil contact.

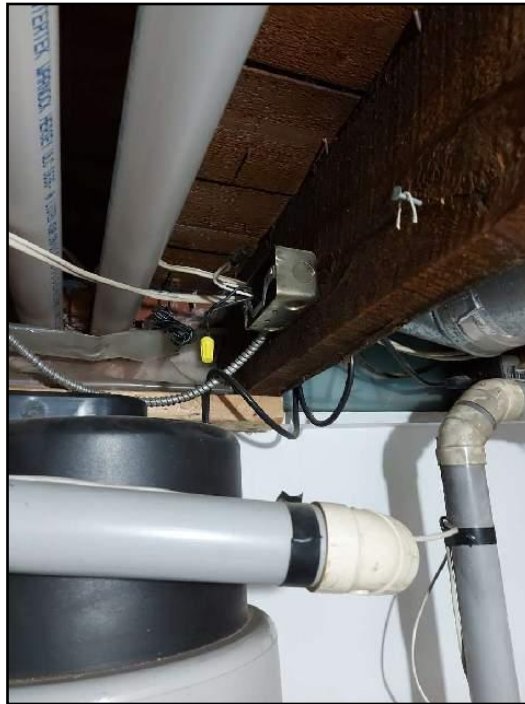
5. Condition: • [Cover loose or missing](#)

Implication(s): Electric shock | Fire hazard

Location: Basement Laundry Area

Task: Provide

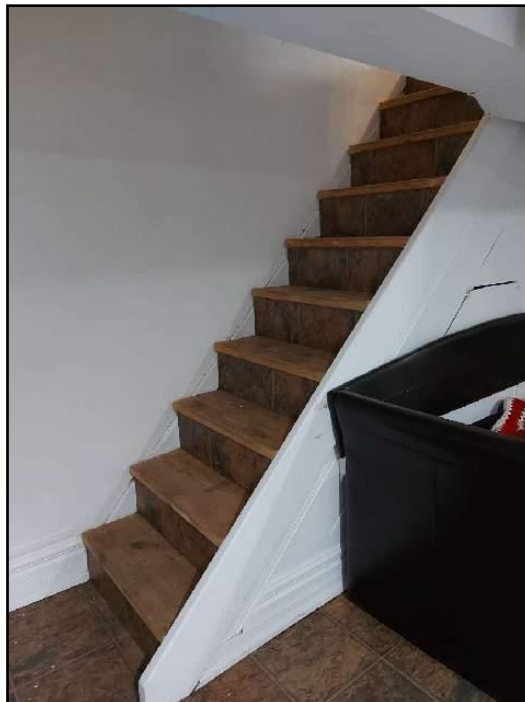
6.

11. Condition: • [Missing](#)

Implication(s): Fall hazard

Location: Basement Staircase

Task: Provide
