Your Inspection Report

580 Merton Street
Toronto, ON M4S 1B3

RE: Report No. 3618
580 Merton Street
Toronto, ON
M4S 1B3

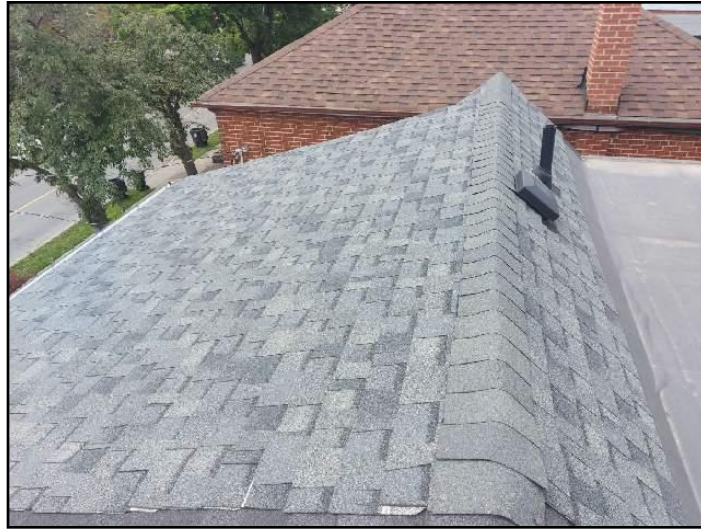
1.

- [Asphalt shingles](#)

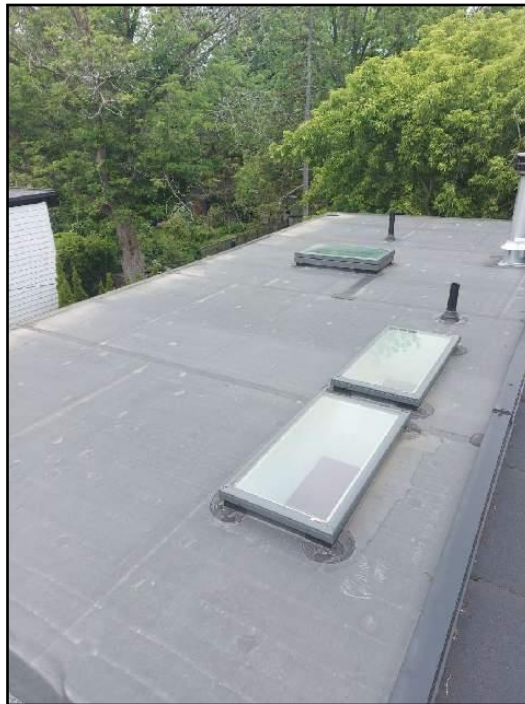
2.

- EPDM

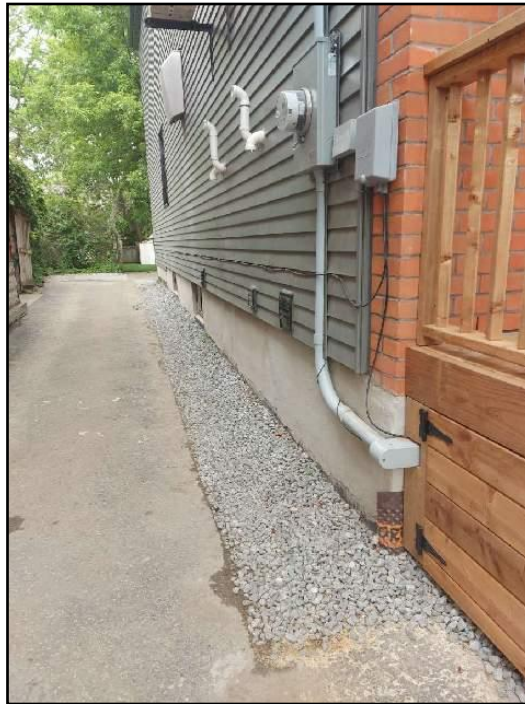
3.

LANDSCAPING \ Driveway
2. Condition: • [Unsealed gap at building](#)
Repave portion of driveway excavated for waterproofing of foundation.
Implication(s): Chance of water damage to structure, finishes and contents
Location: North Exterior
Task: Repair
Time: Unpredictable
Cost: Consult contractor for cost

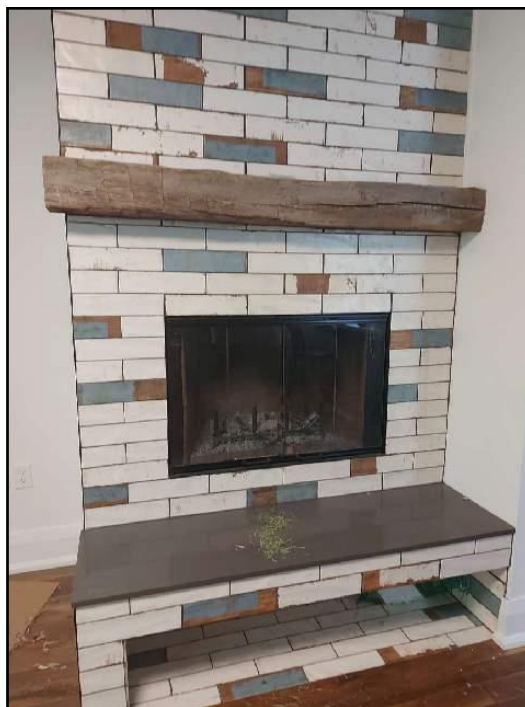
4.

• [Wood-burning fireplace](#)

• [Factory-built](#)

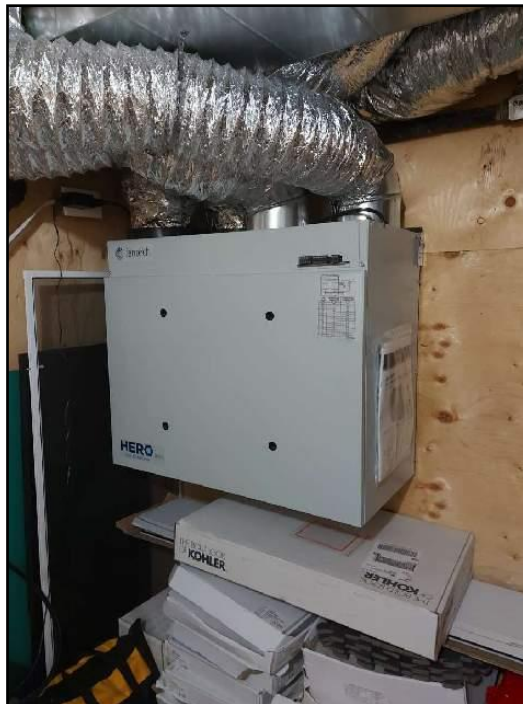
5.

- Heat recovery ventilator (HRV)

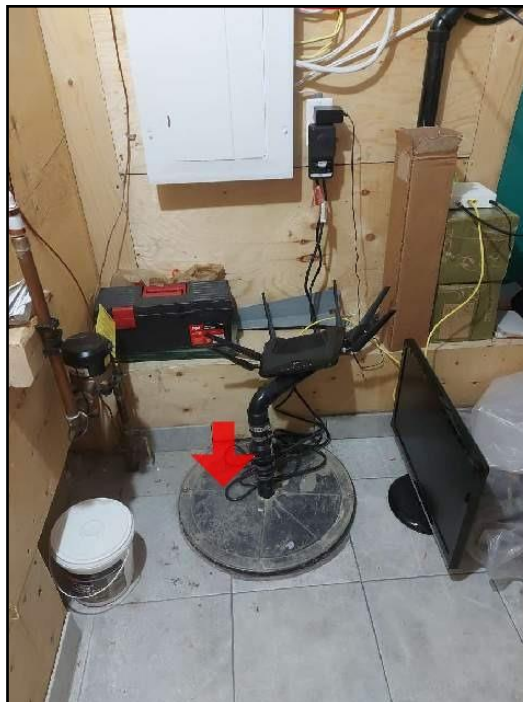
6.

• [Sump pump](#)

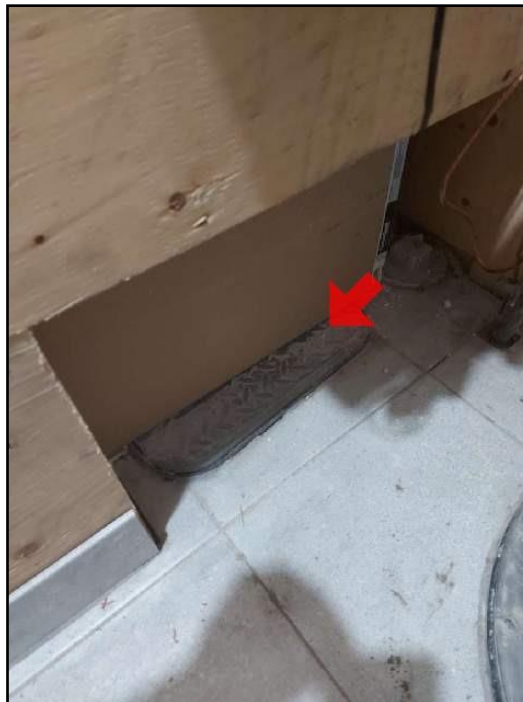
7.

• Present. These valves help prevent sewer backup. Many insurance companies insist these be installed before they will

offer a sewer backup endorsement, which we strongly recommend you obtain.

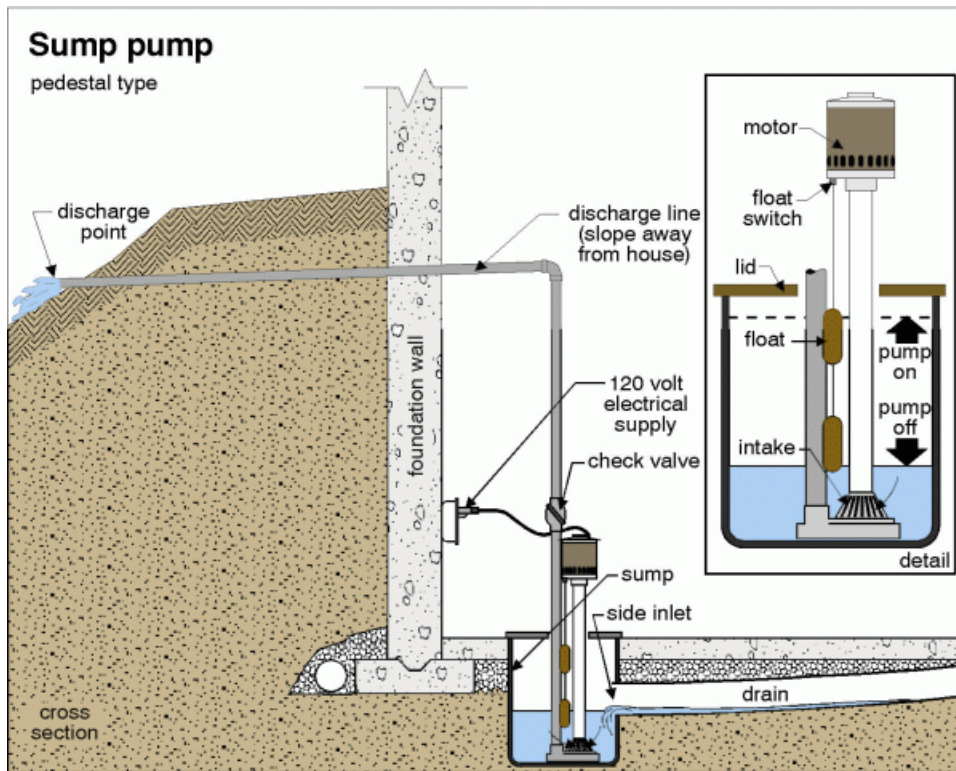
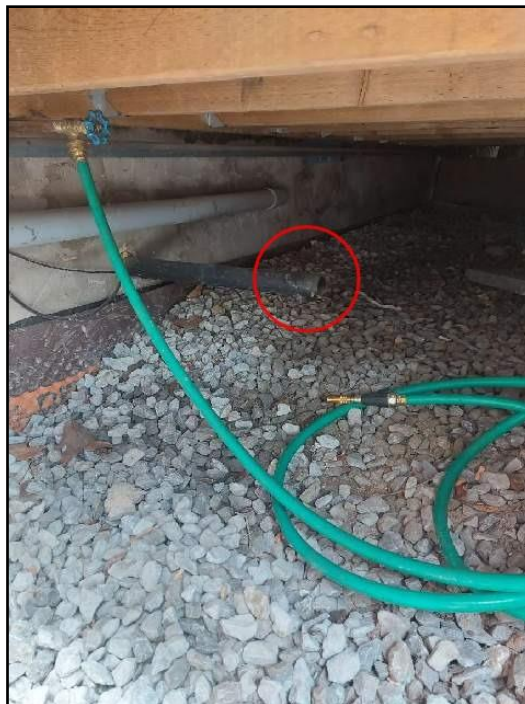
8.

9. Condition: • [Discharges less than 6 feet from home](#)

Location: South Exterior (under porch)

Extend discharge further from foundation.

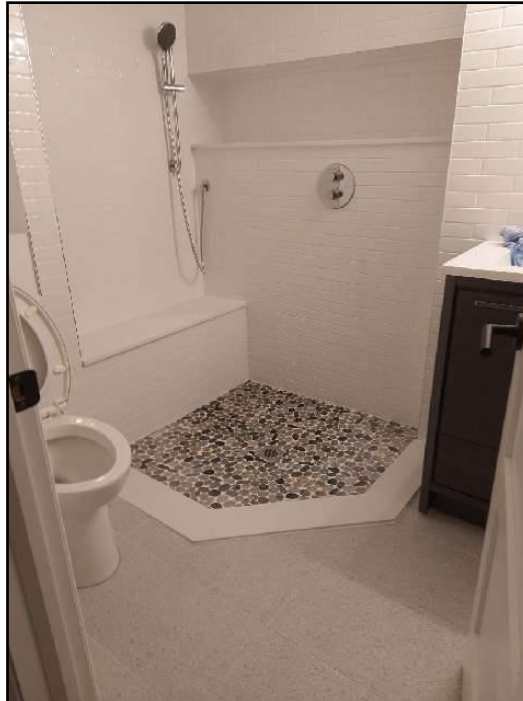
9.

11. Condition: • Vendor to have shower glass installed and base of shower stall caulked.

Location: Basement Shower

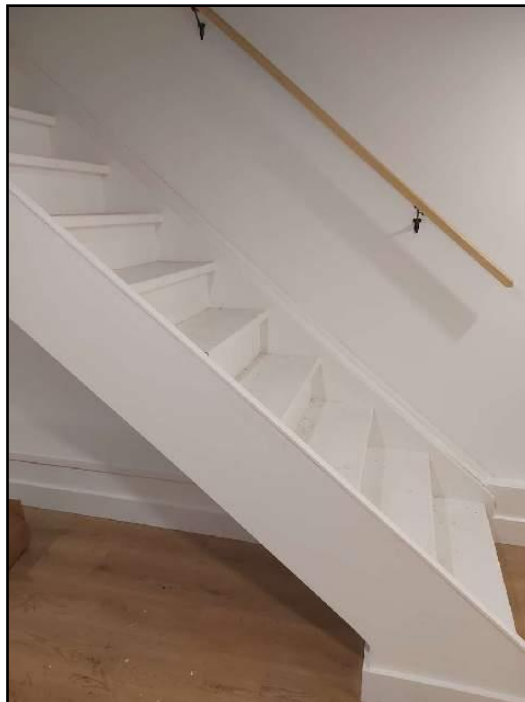
10.

12. Condition: • [Missing](#)

Implication(s): Fall hazard

Location: Basement Staircase

Task: Provide

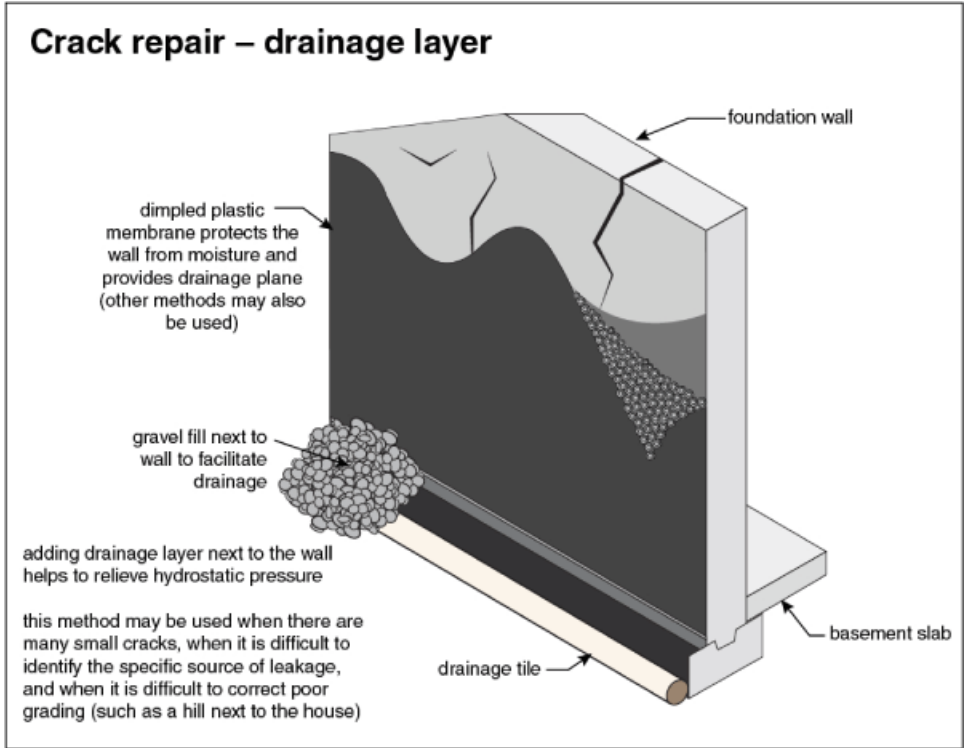
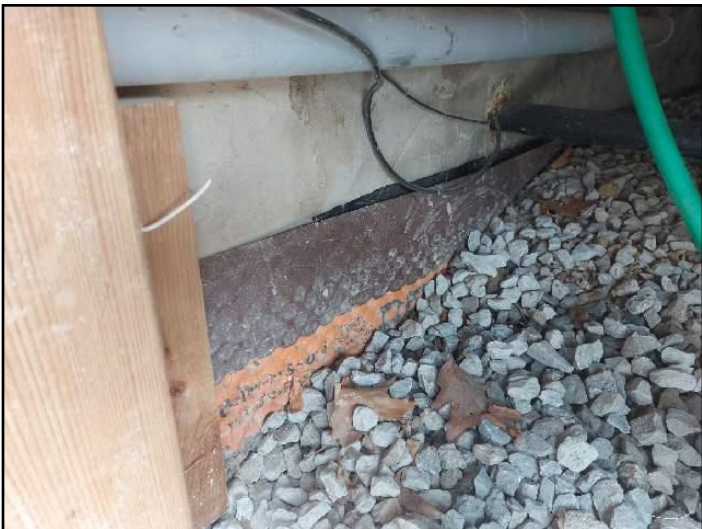
13. Condition: • [Drainage membrane](#)

Very low potential for basement leakage due to presence of exterior foundation membrane connected to sump system.

Location: Throughout Exterior
