Your Inspection Report

118 Torbrick Road
Toronto, ON M4J 4Z5

Friday, September 8, 2023

RE: Report No. 3863
118 Torbrick Road
Toronto, ON
M4J 4Z5

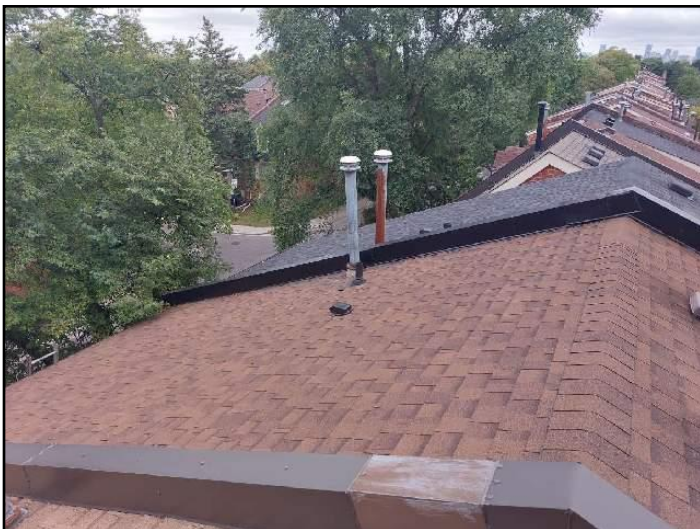
1.

Sloped roofing material:

- [Asphalt shingles](#)

Probability of leakage: • Low

Approximate age: • 6 years

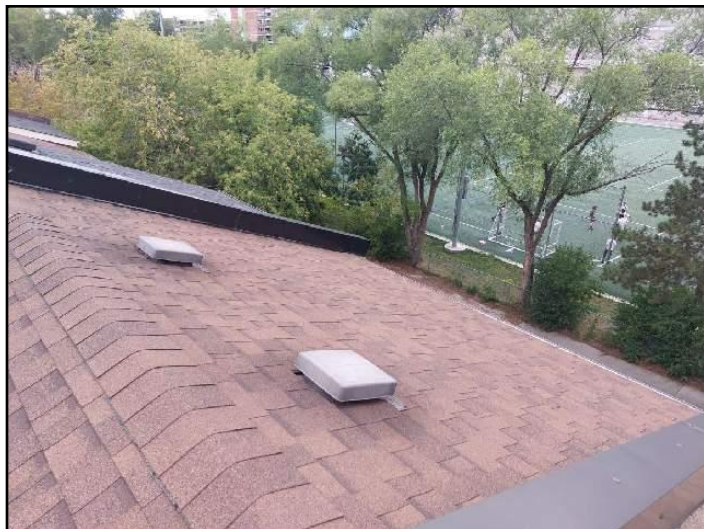
2.

1. **Condition:** • No roofing recommendations are offered as a result of this inspection. Roof in good condition.

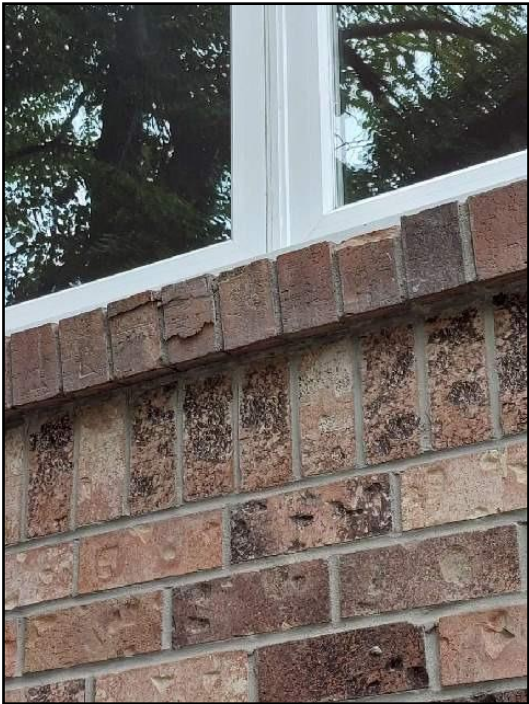
3. Condition: • [Spalling](#)

Minor masonry repair needed at first floor window sill.

Implication(s): Weakened structure | Chance of structural movement

Location: South Exterior

Task: Repair or replace

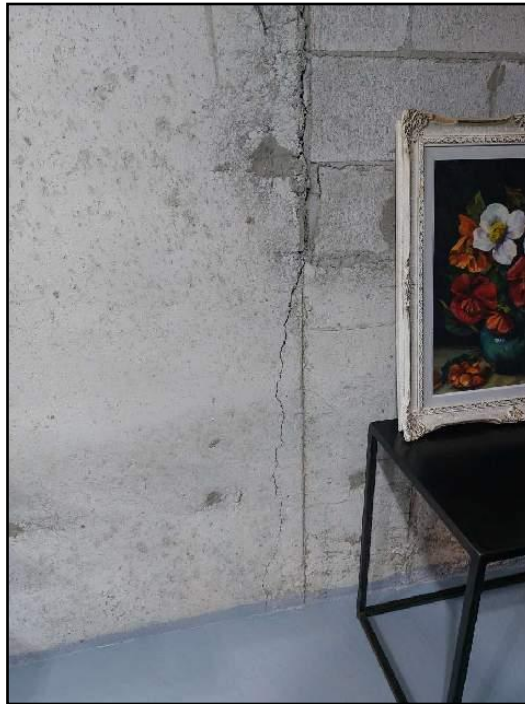
4. Condition: • Typical minor cracks
Typical minor cracks are not structurally significant. Cracks are at party wall and therefore not vulnerable to leakage.

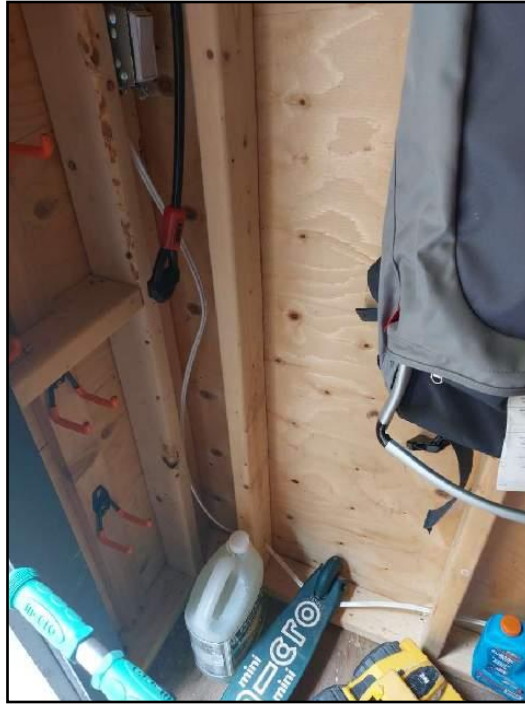
5. Condition: • Cover exposed wiring with conduit.

Location: Exterior

Task: Protect

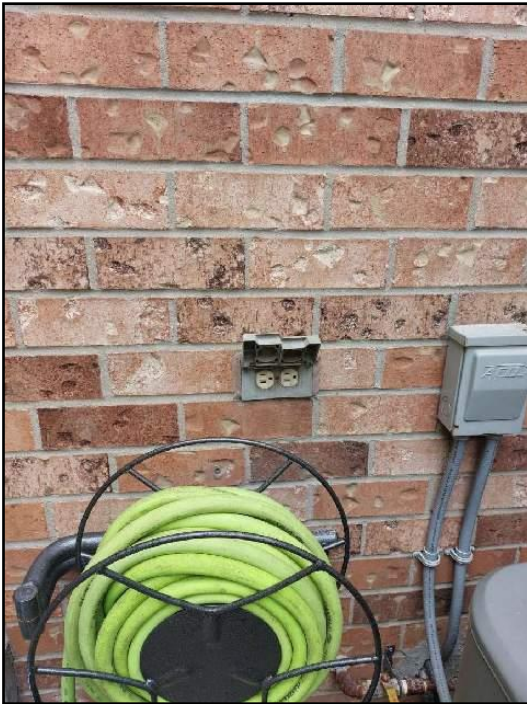
6. Condition: • [GFCI/GFI needed \(Ground Fault Circuit Interrupter\)](#)

Implication(s): Electric shock

Location: Exterior

Task: Replace

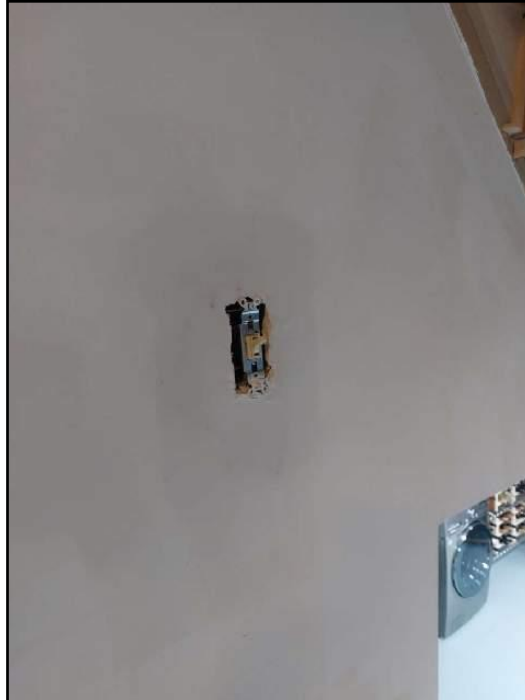
7. Condition: • [Missing](#)

Implication(s): Electric shock

Location: Basement and shed

Task: Provide

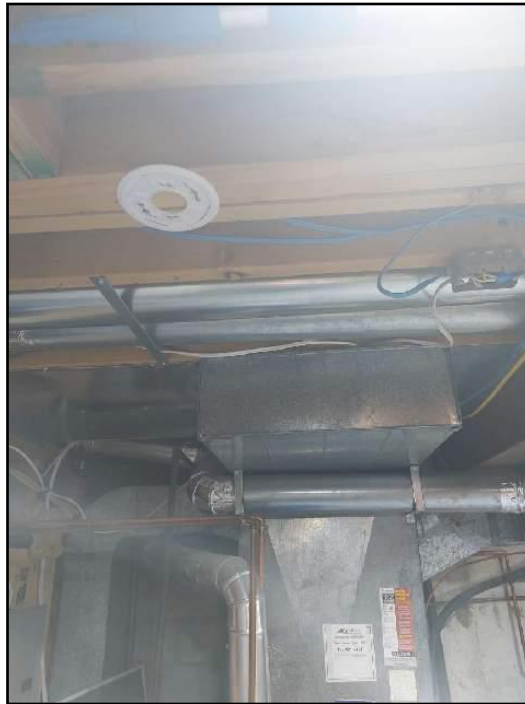
8. Condition: • Missing

Implication(s): Safety issue

Ensure each floor has operable smoke/carbon monoxide detectors.

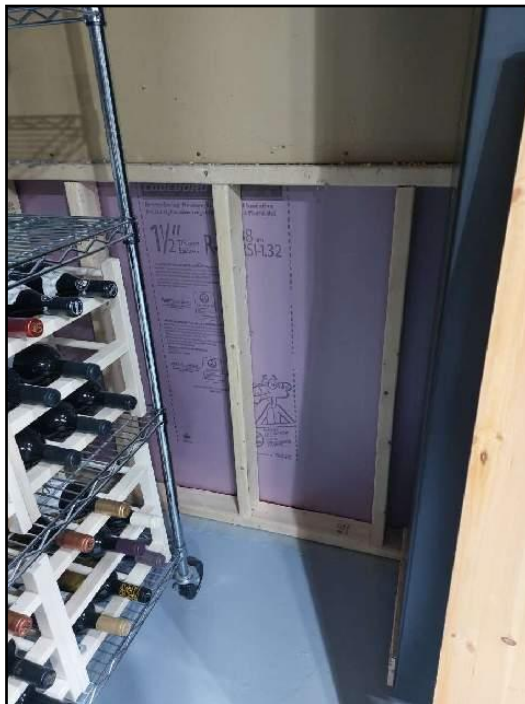
9.

12. **Condition:** • [Exposed combustible insulation](#)

Implication(s): Fire hazard

Location: North Basement

Remove styrofoam or cover with drywall.

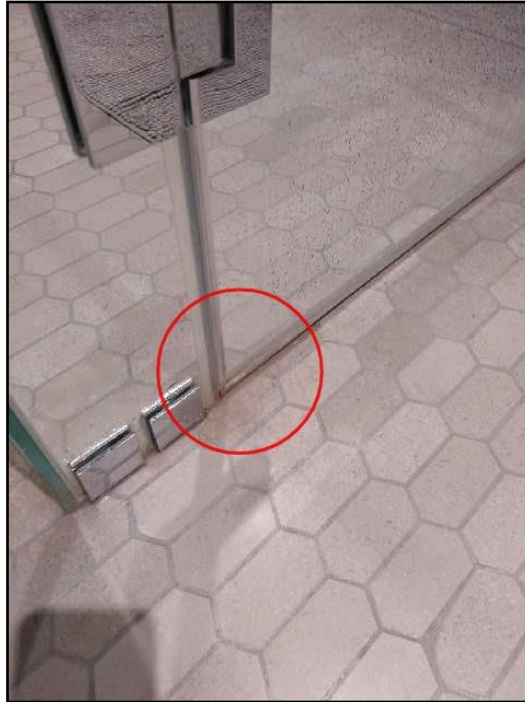
10.

13. Condition: • [Pooling water on the floor](#)

Implication(s): Chance of water damage to structure, finishes and contents

Location: Third Floor Ensuite Bathroom

Replace threshold strip at base of shower door.

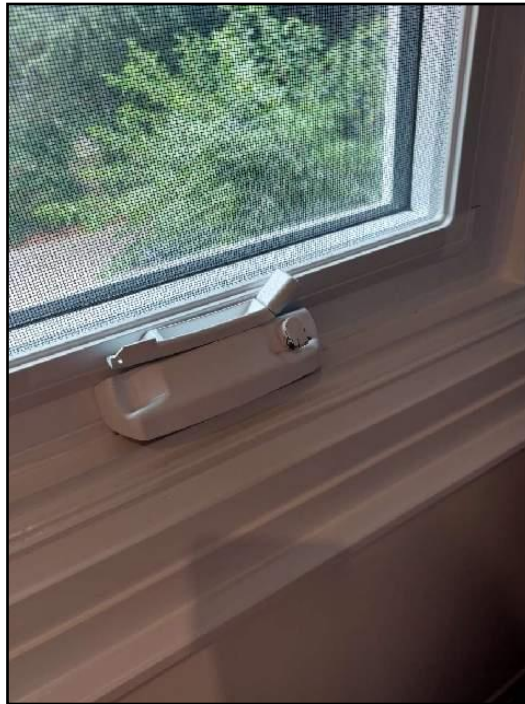
11.

14. Condition: • [Broken](#)

Implication(s): System inoperative or difficult to operate

Location: North Second Floor Bedroom

Task: Replace

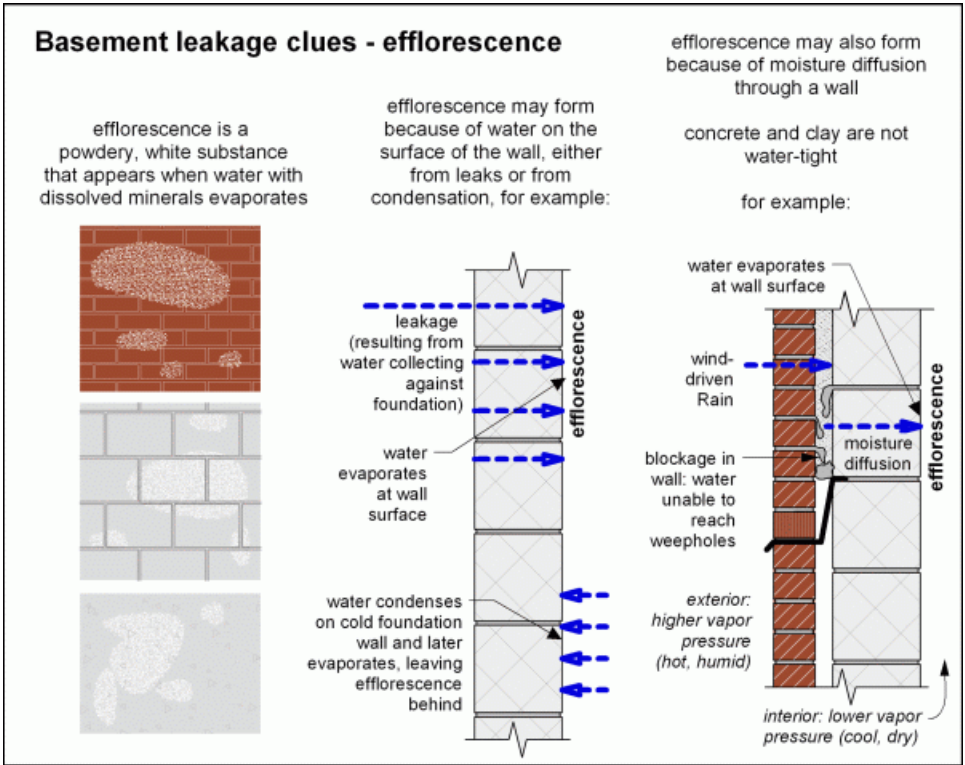
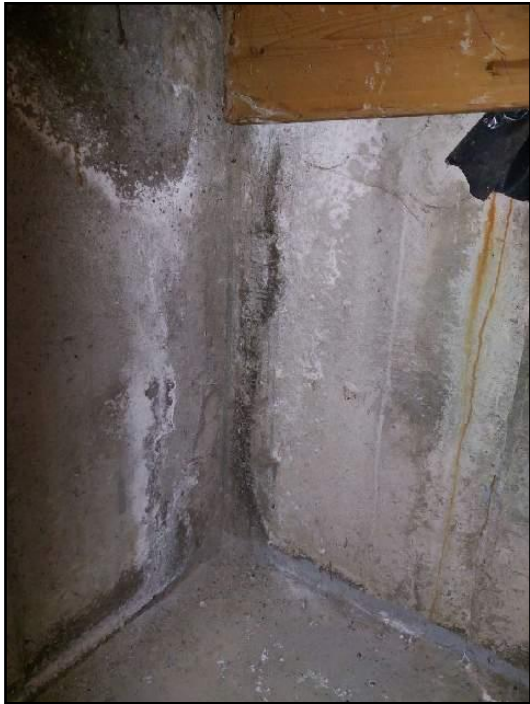
12.

15. Condition: • [Efflorescence](#)

Typical minor efflorescence. Install interior membrane before insulating crawlspace.

Implication(s): Chance of water damage to structure, finishes and contents

Location: South Crawl Space
