Your Inspection Report

139 Hogarth Avenue
Toronto, ON M4K 1K5

Monday, November 6, 2023

Aitken Home Inspections
49 Riverdale Ave
TORONTO, ON M4K 1C2

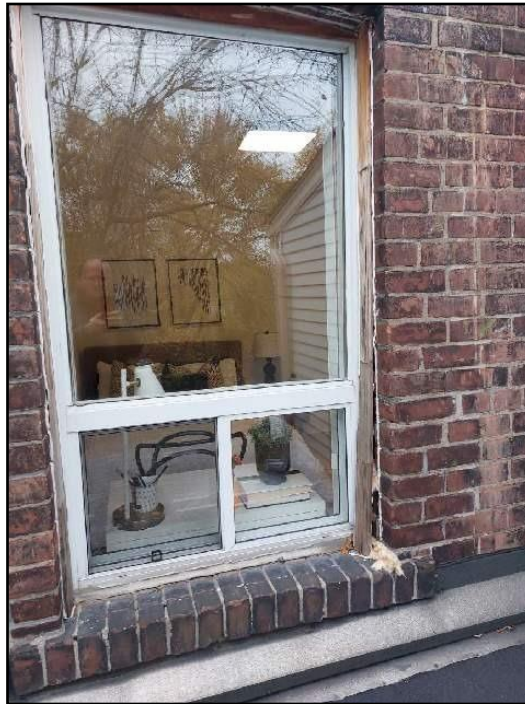
6.

WINDOWS \ General notes

4. Condition: • Damage

Implication(s): Increased heating and cooling costs | Reduced comfort

Location: Southwest Second Floor

Task: Repair or Replace

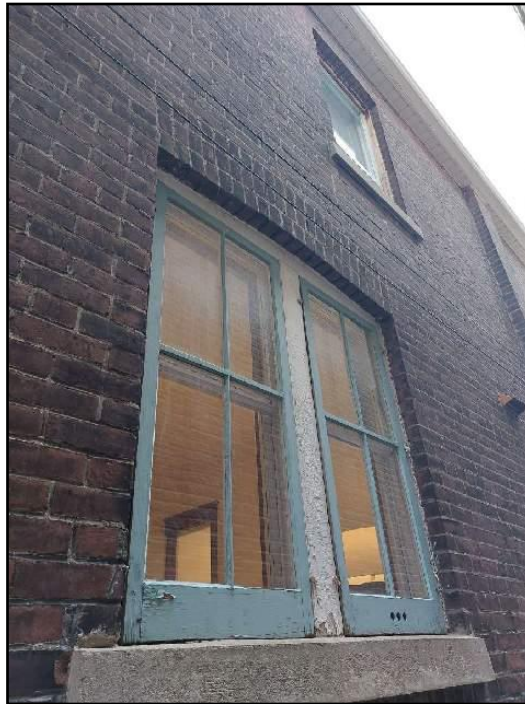
7.

EXTERIOR GLASS/WINDOWS \ Exterior trim

5. Condition: • Paint and caulking maintenance needed.

Wood windows and trim due for prep and paint if not replacing.

Location: Various Exterior

Task: Improve

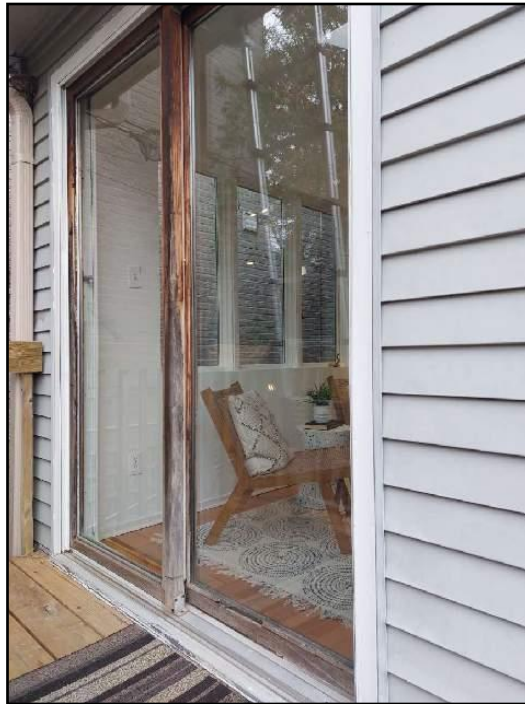
8.

DOORS \ General notes

6. Condition: • Damage

Location: South First Floor Exterior

Task: Replace

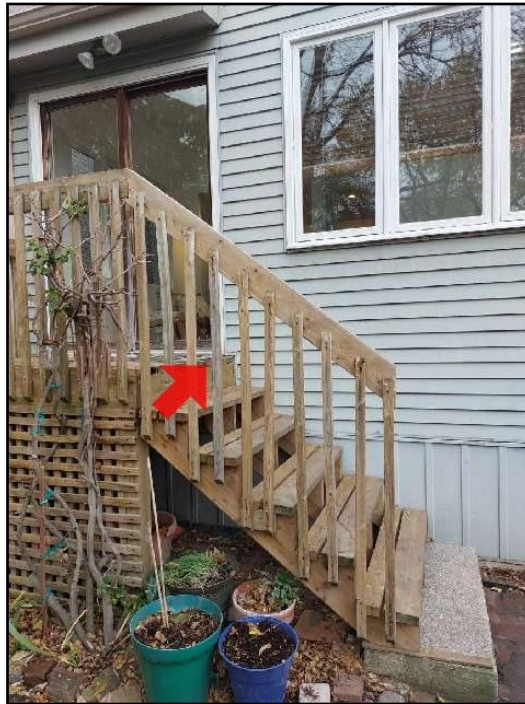
9.

PORCHES, DECKS, STAIRS, PATIOS AND BALCONIES \ Handrails and guards

7. Condition: • [Loose](#)

Implication(s): Fall hazard

Location: South Exterior Stairs

Task: Repair

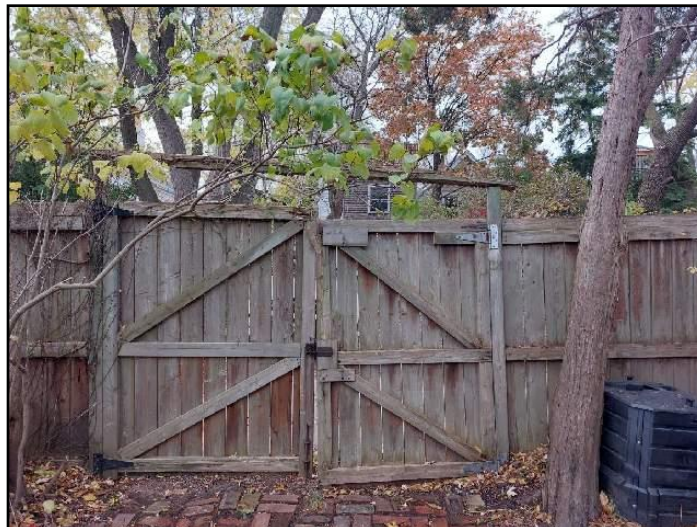
10.

LANDSCAPING \ Fence

8. Condition: • Deteriorated

Implication(s): Material deterioration

Location: South Exterior

Replace south fence and gate for vehicle access.

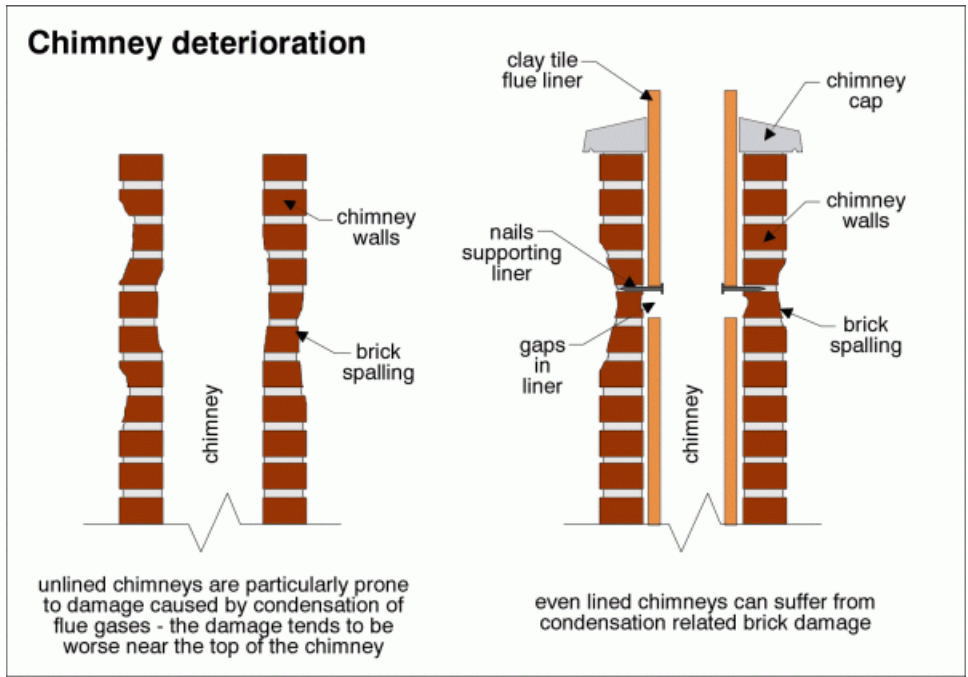
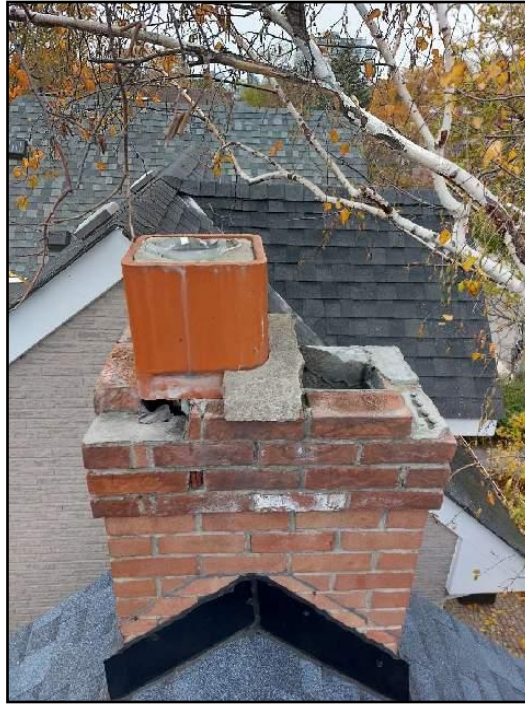
CHIMNEY AND VENT \ Masonry chimney

12. Condition: • [Loose, missing or deteriorated masonry](#)

Implication(s): Material deterioration

Location: Northwest Exterior

Replace missing cap at metal liner for water heater, seal open flue against pest and water entry (if not restoring fireplace). Repair damaged masonry.

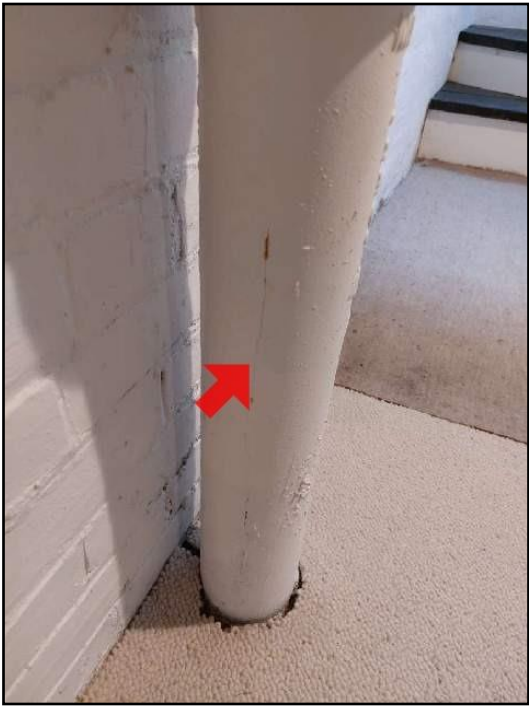
13.

WASTE PLUMBING \ Drain piping - performance

17. Condition: • [Split, damaged, crimped pipe](#)

Implication(s): Chance of water damage to structure, finishes and contents | Sewage entering the building

Location: Southeast Basement

Original cast iron waste piping in use. replace as needed or when renovating.

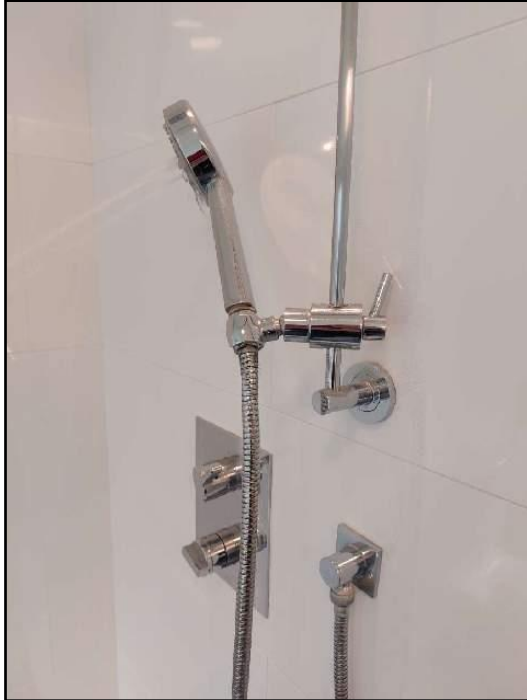
14.

FIXTURES AND FAUCETS \ Faucet

18. Condition: • [Drip, leak](#)

Implication(s): Chance of water damage to structure, finishes and contents

Location: Various

Task: Repair

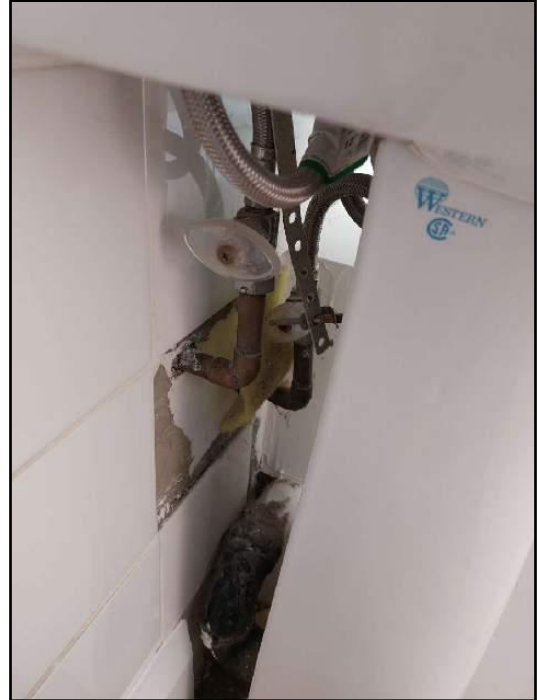
15.

19. Condition: • [Loose](#)

Implication(s): Equipment failure

Location: Second Floor Bathroom

Task: Repair

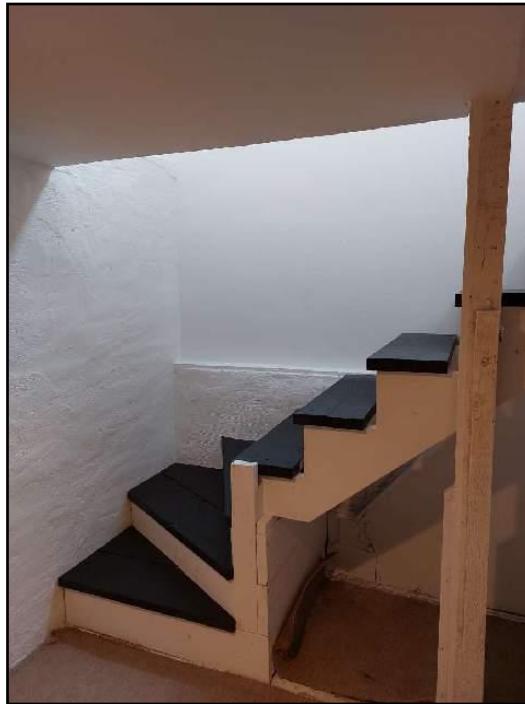
17.

STAIRS \ Height

22. Condition: • [Headroom less than ideal](#)

Implication(s): Physical injury

Location: Basement Staircase

Post caution at awkward basement stairs until renovation allows for reconfiguration.

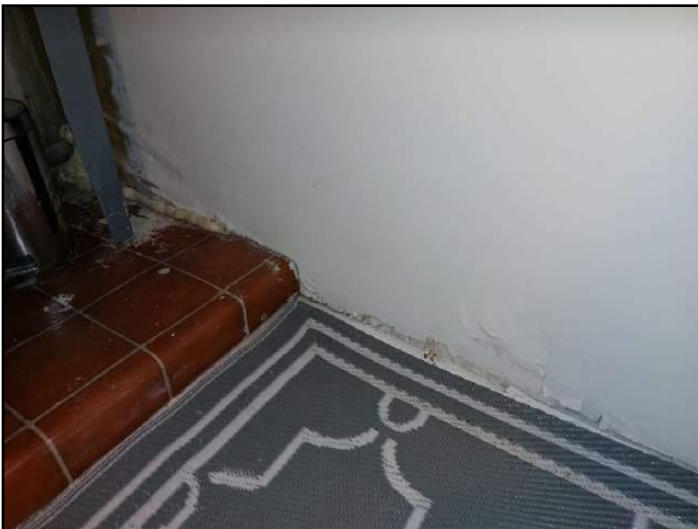
18.

BASEMENT \ Wet basement - evidence

23. Condition: • [Stains](#)

Typical dampness and efflorescence at basement. Install interior or exterior membrane.

Implication(s): Chance of water damage to structure, finishes and contents

Location: Various Basement
