Your Inspection Report

166 Pacific Avenue
Toronto, ON M6P 2P5

Tuesday, April 23, 2024

RE: Report No. 3972, v.3
166 Pacific Avenue
Toronto, ON
M6P 2P5

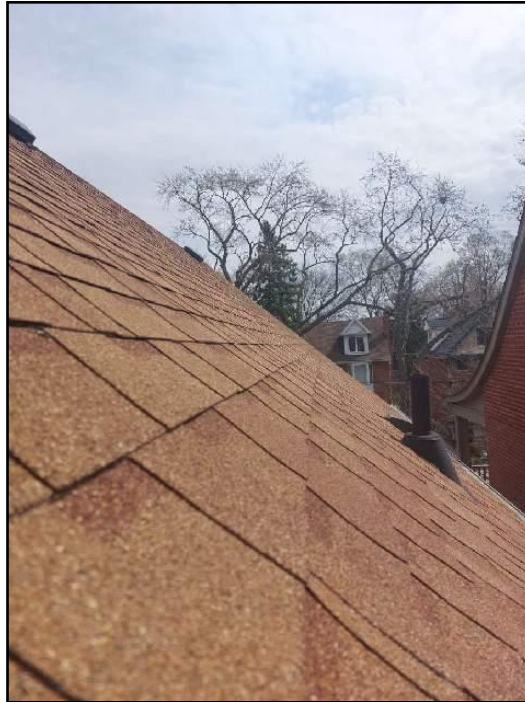
1.

- [Asphalt shingles](#)

- 9 years
At garage
- 13 years
At house

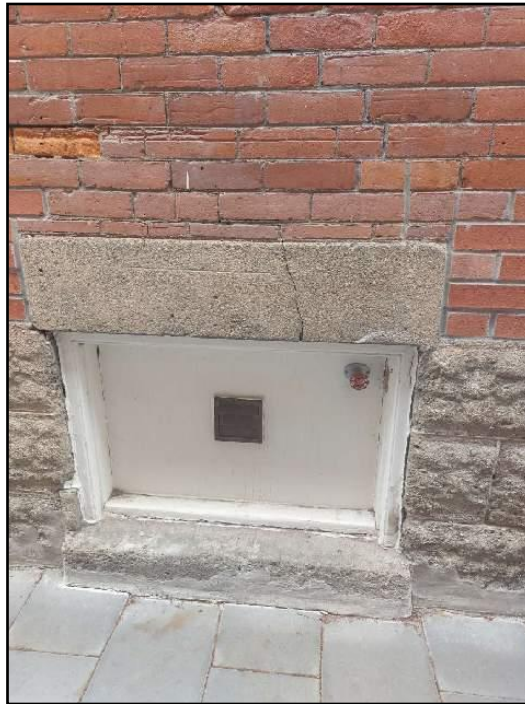
2. Condition: • Typical minor cracks, not structurally significant.

Location: Southwest Basement

Replace lintel stone with steel if restoring basement window (not urgent).

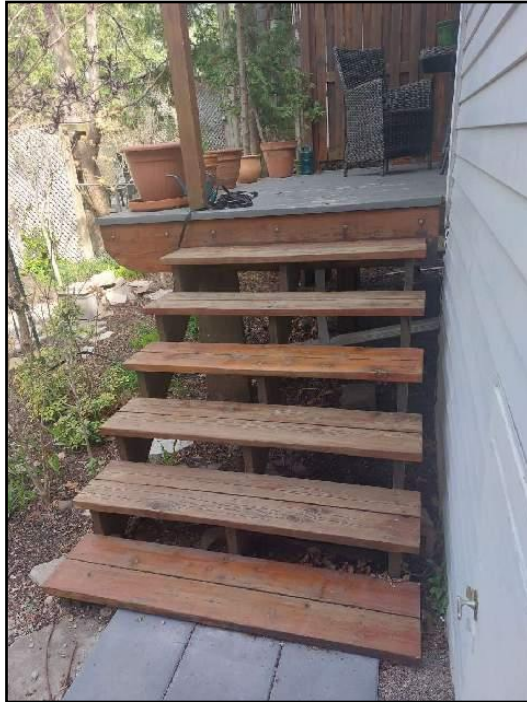
3. Condition: • Add guardrail and eliminate trip hazard at bottom step.

Location: West Exterior Deck

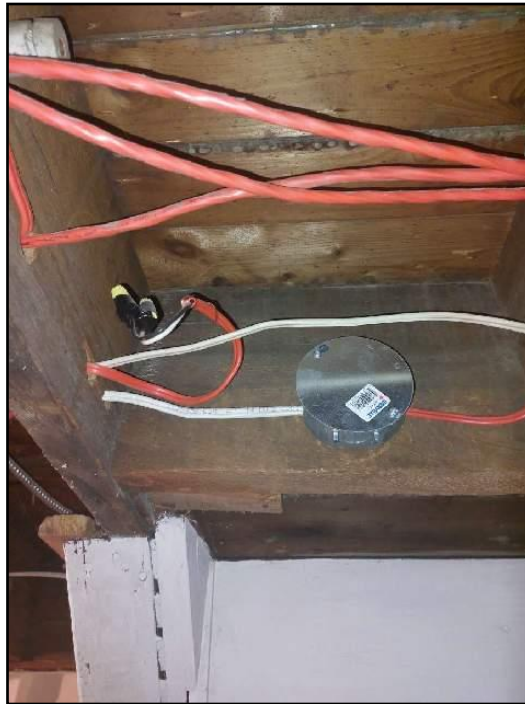
4.0

6. Condition: • [Abandoned wire](#)

Implication(s): Electric shock

Location: S/E Basement

This has been repaired since inspection.

Terminate wire in junction box.

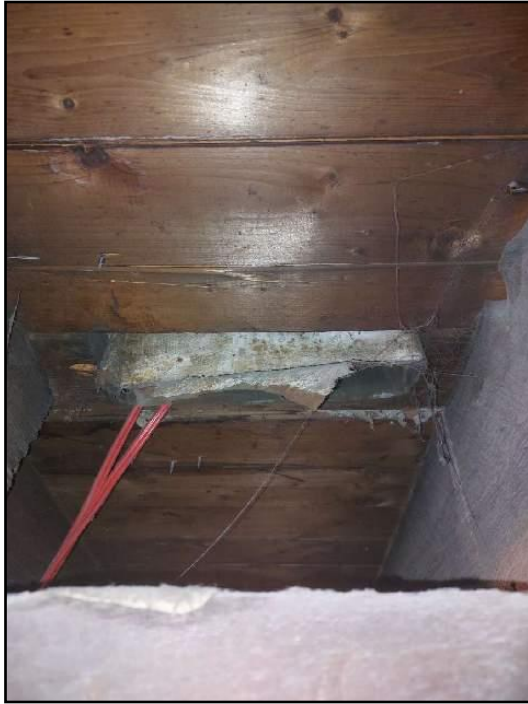
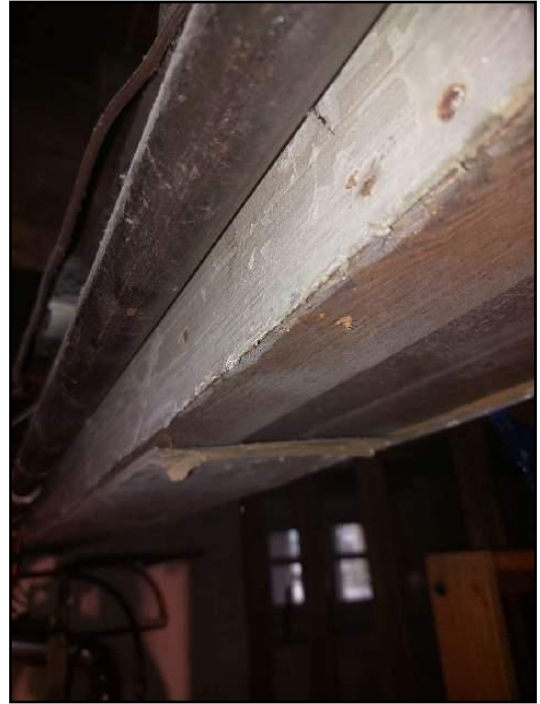
7. **Condition:** • Typical for this era of construction, some asbestos appears to be present at basement beam and unused ducting. Remove if necessary to disturb.
Location: Various
Task: Further evaluation

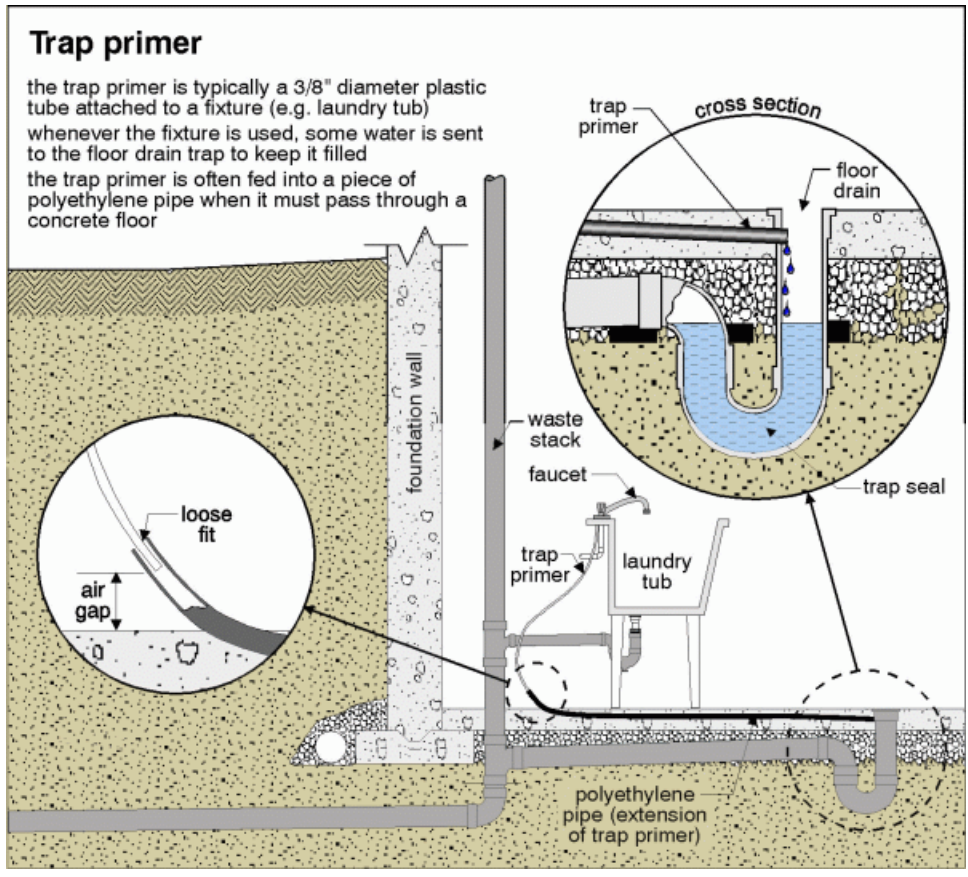
10. Condition: • [No primer or poor primer arrangement](#)

Trap at floor drain is dry, add water periodically to prevent odours, add primerline if renovating.

Implication(s): Sewer gases entering the building

Location: Southwest Basement

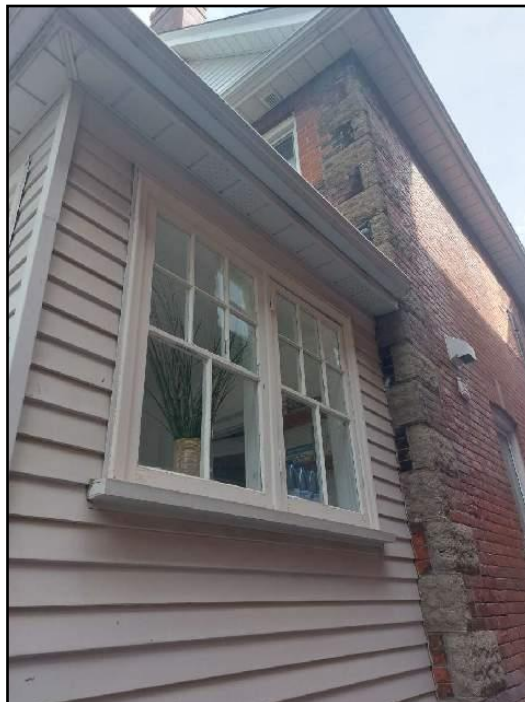
7.

11. Condition: • [Original lower quality units](#)

Implication(s): Increased heating costs | Increased maintenance costs

Location: Mudroom

Task: Replace

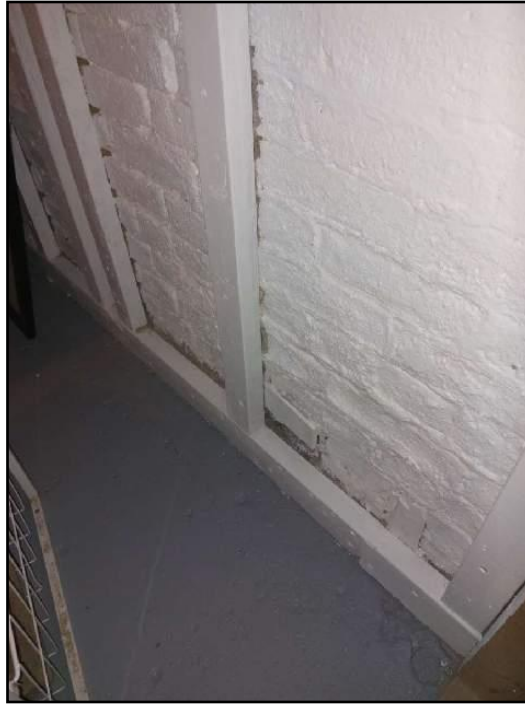
9.

13. Condition: • [Efflorescence](#)

Typical efflorescence evident at basement, install interior membrane if renovating basement.

Implication(s): Chance of water damage to structure, finishes and contents

Location: Various Basement
