# Your Inspection Report

75 Browning Avenue  
Toronto, ON M4K 1W1

Tuesday, October 6, 2020

RE: Report No. 3174  
75 Browning Avenue  
Toronto, ON  
M4K 1W1

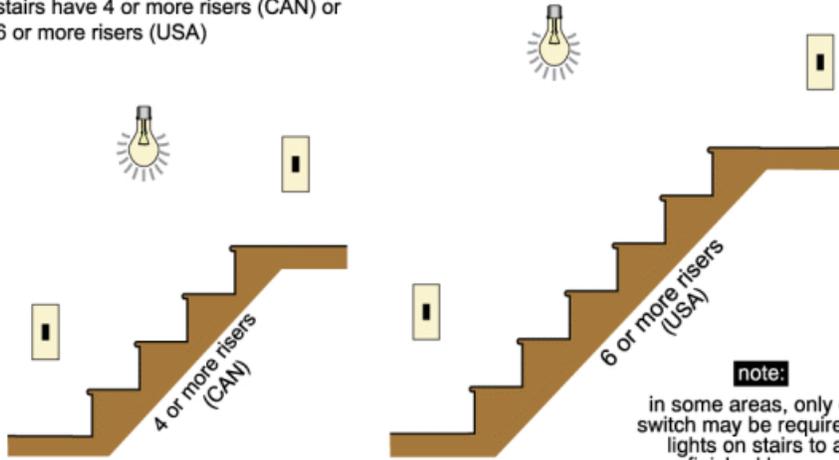
## Stairway lighting

stairway lighting requires switches at both the top and bottom of the stairs when the stairs have 4 or more risers (CAN) or 6 or more risers (USA)
