# **Your Inspection Report**

## 308 St George St Toronto, ON M5R 2P5

**PREPARED BY:** Jim Gibson, P.Eng.

RE: Report No. 74041 308 St George St Toronto, ON M5R 2P5

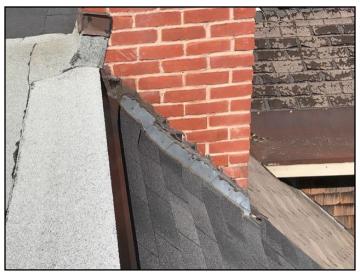
Condition: • Counter flashing - installation nonstandard, patched

Flashing - patched

Task: Monitor/repair

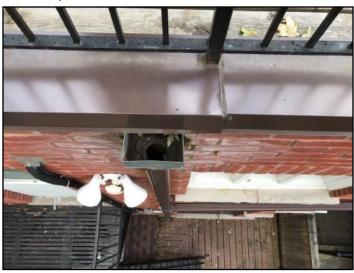
Roof drain/scupper - vulnerable area...

Leak

Condition: • Roof drain/scupper - vulnerable area for clogging, freezing and leaks

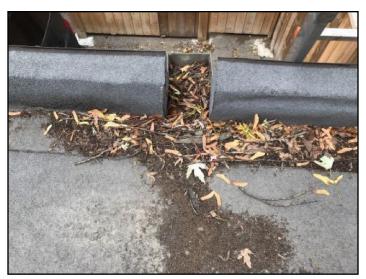
Roof drain/scupper - vulnerable area...

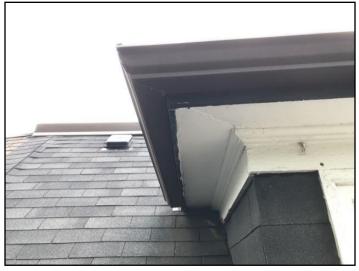
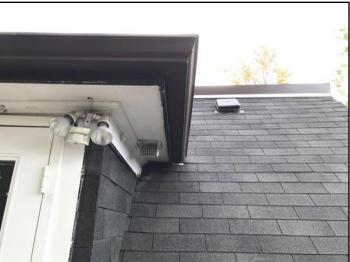
**Condition:** • Discharge onto roofs **Location**: Rear third floor dormer

Discharges onto roof

Task: Provide downspouts from upper to upper gutters

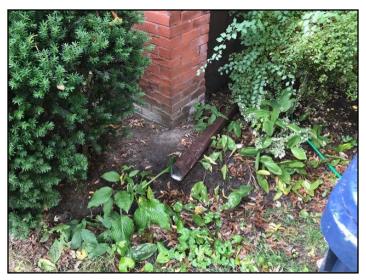
Condition: • Discharges too close to masonry column

Discharges too close to masonry column

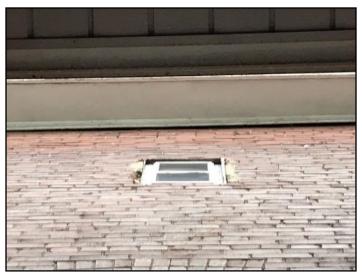
Condition: • Window - installation incomplete/low quality, abandoned

Window - installation incomplete...

Task: Repair

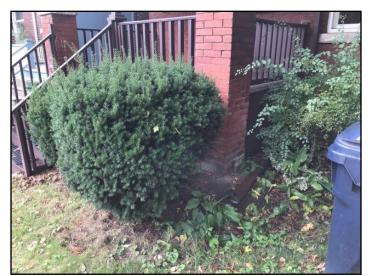
Condition: • Porch and stairs - access restricted underneath, wood/soil contact

Porch - access restricted underneath

**Task**: Further evaluation / Repair **Time**: Less than one year

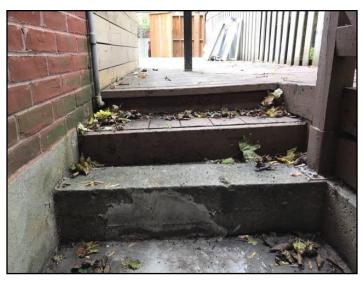
Condition: • Stairs - riser height uneven Location: Right rear basement walkout

Stairs - riser height uneven

Task: Repair

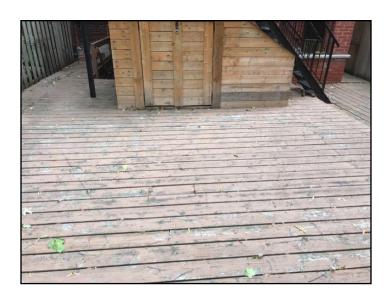
Condition: • Lot grading - not visible (due to deck)

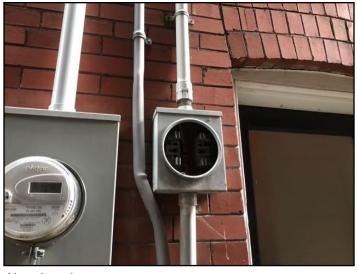
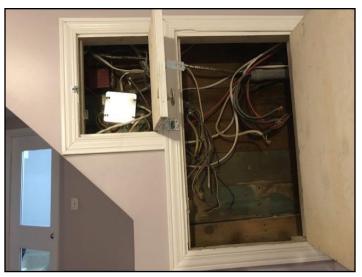
Abandoned Abandoned

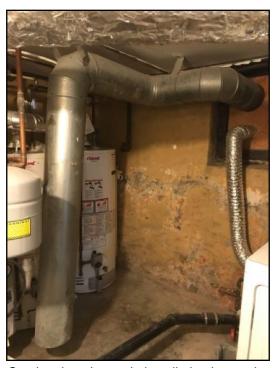
Condition: • Combustion air supply - installation incomplete ("J" termination missing)

Combustion air supply-installation incomplete

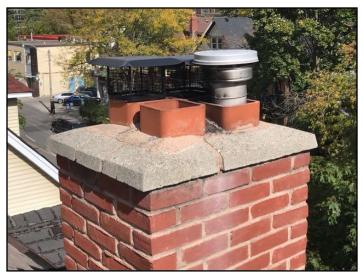
Condition: • Weather cap - missing

Weather cap - missing

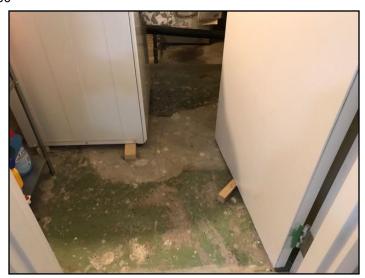
Condition: • Floor drain - not visible

Floor drain - not visible

Task: Provide

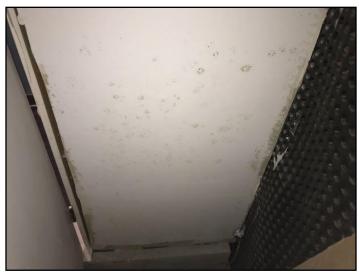
Condition: • Mould

Location: Rear basement bathroom closet

Mould

Task: Remove drywall Time: Immediate Cost: Minor
